GA355.16

Assembly/disassembly recommendations

IDENTIFICATION OF TENSIONER ROLLER GA355.16

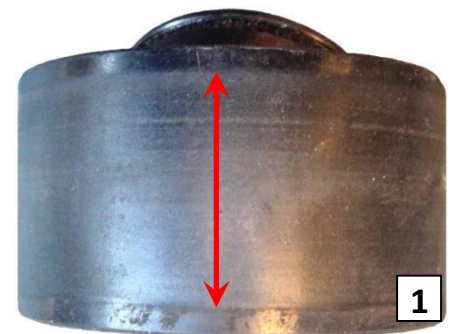
A defective alternator overrunning pulley

When worn or seized the overrunning alternator pulley does not disengage correctly, this means the alternator can't free wheel when needed. This generates an up and down snatching motion on the belt.

GA355.16 is not designed to absorb the violent shocks caused by the belt, this allows the belt to become incorrectly tensioned allowing it to slip on the rollers (**FIG 1**).

The slipping belt creates heat on the outer diameter of the tensioner roller pulley. This causes a rise in temperature inside the pulley, causing it to fail.

Failures with GA355.16 are often caused by a faulty overrunning alternator pulley. Overrunning alternator pulleys should be checked or replaced at the same time as the tensioner roller assembly is replaced.

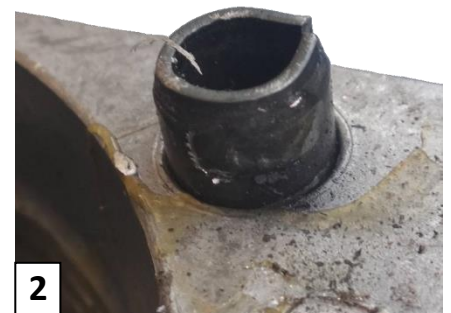
Another sign of an overrunning alternator pulley failure is the tensioner roller assembly stop shows traces of impact and is generally damaged normally bent. This failure is associated with excessively large roller displacement (**Fig 2**).
