Failure of turbocharger, weak performance, loud noises, heavy smoke development, increased bearing clearance, one vane of the compressor wheel is bent

This service information is valid for the exchange of the turbocharger with **BTS reference:** T912318;

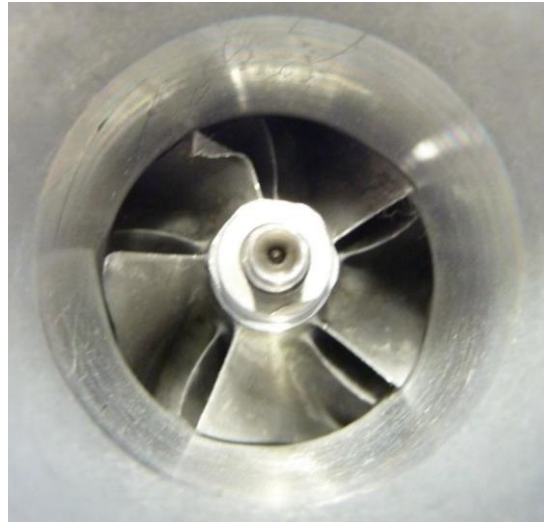
If one of the vanes of the compressor wheel is bent (see picture) the complete suction area should be checked and cleaned.

Under certain conditions water and oil may freeze in the engine ventilation.

This icy mixture will then be sucked in by the turbocharger and will lead to a foreign body damage.

A damage looking like this may also be the result of soft parts loosening in the suction area (such as rubber parts etc.) that are then also sucked in.

Check the air suction area for any dirt or residue and clean it!
