Boost pressure too low / too high – temperature below -15°C:

Vehicle Manufacturer: Ford

Vehicle: Mondeo III / Ford Transit

Engine Code: FMBA / N7BA / FIFA

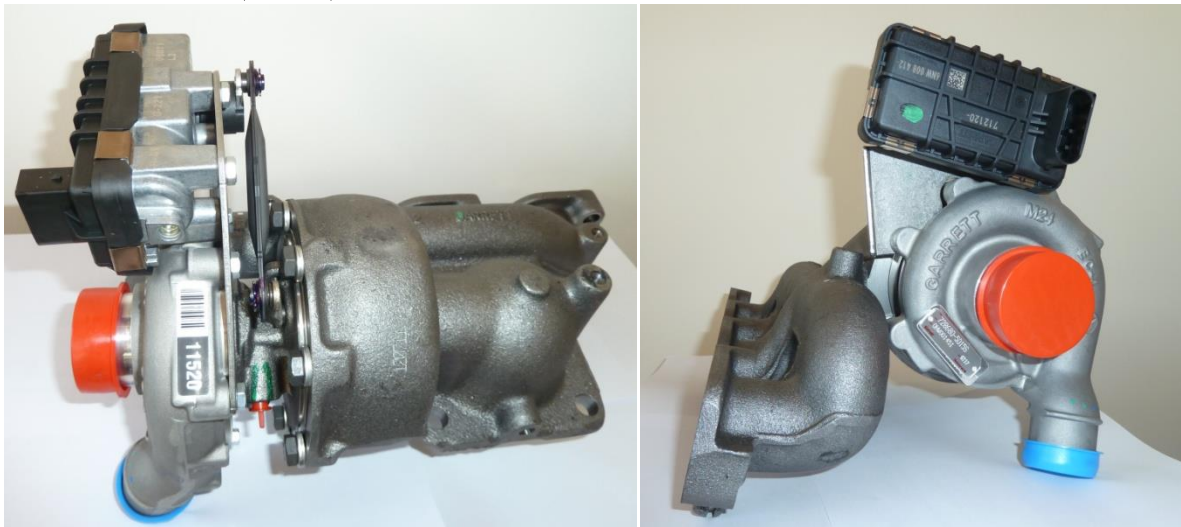
But Ford states the use of **silver-calcium batteries** for these models as mandatory. The reason is that the actuator has to be operable with lower electrical voltage. Under extremely cold temperatures e.g. **calcium-calcium batteries** are not able to transmit the necessary voltage. The result is an error from the electronic actuator back to the engine control unit with „boost pressure too low / too high“.

Please note: The error does not occur anymore if the vehicle has been standing in the workshop for about 1 hour (warm).

Solution: Check the battery and exchange if necessary. In a lot of cases cheaper batteries are installed into older vehicles.
