**Weak performance, vehicle in fail-safe mode
Indicator lights for ESP and MIL are turned on
Waste gate is stuck or moves only with difficulty**

Vehicle Manufacturer: MERCEDES-BENZ

Vehicle: SPRINTER

Engine Code: OM 651.957

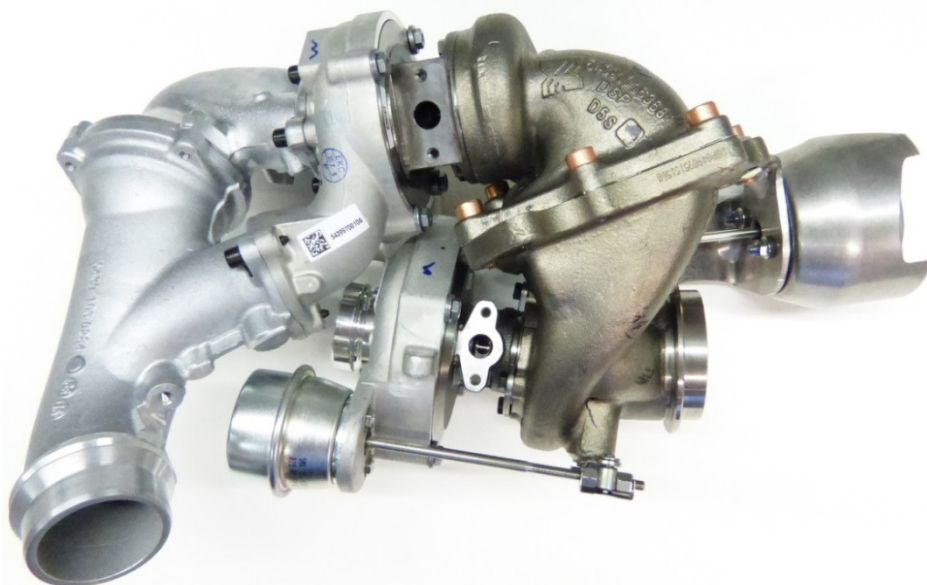
Up to engine number xxx31794909 the connection of the air pipe on the compressor may have changed. Therefore, you may need the following parts from OE in order to be able to install the new turbocharger

A 906 528 50 82	air pipe	A 651 096 29 40	bracket
A 906 501 14 82	coolant pipe	A 651 096 30 40	bracket
N 910 143 006 002	screw M6X20 (10x)
