Lack of performance, shaft nut detached, increased bearing clearance, lack of lubrication due to oil pump breakdown

Vehicle Manufacturer: Audi, Seat, Skoda, VW

Vehicle: All models with a 2.0 TDI

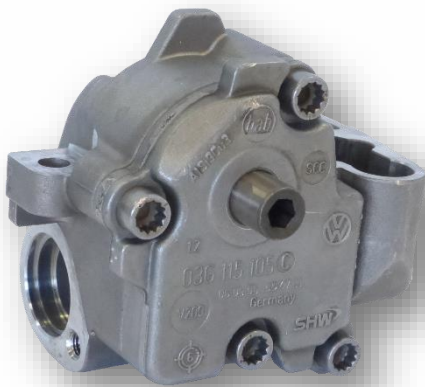
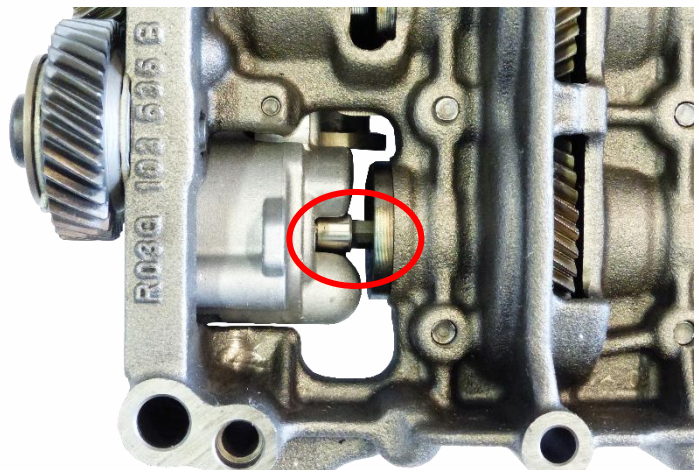
A loosened or detached shaft nut is an unequivocal indicator of a damage caused by a lack of lubrication. Another possible damage type caused by a lack of lubrication can be a broken rotor shaft. The reason for a lack of lubrication is a sudden decrease of the oil pressure which is caused by the drive of the oil pump. Load alternations during travel operation cause a premature abrasion of the hexagon drive shaft (marked in red in below image) between the oil pump and the momentum balancing element. (Defective dual mass flywheels intensify the abrasion). There will be no oil pressure which in conclusion will cause a turbocharger damage due to a lack of lubrication.

The oil sump is to be removed and the hexagon drive shaft is to be checked. The shaft must be able to move lengthwise and mustn't have any radial clearance. In unfavourable cases the hexagon shaft is wedged in the counterpart which implies the false impression that everything is okay.
