Failure of turbocharger, whistling noises and lack of performance**Please note:**

Vehicle manufacturer: BMW

Validity: This service information is valid for the exchange of the turbocharger with **BTS reference:** T914870;

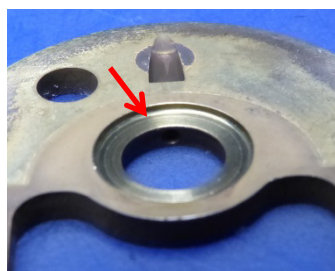
If the turbocharger on the vehicles below fails after being exchanged, the exhaust back pressure is most likely too high, leading to a damage on the axial bearing of the rotorshaft. The damage on the turbocharger usually results in an extremely increased axial bearing clearance, leading to the turbine wheel grazing on the heatshield of the turbine housing and the compressor wheel grazing on the compressor housing. The driver will probably notice shrieking whistling noises and a starting lack of performance.

Axial bearing
worn by axial thrust

Insert a T connector along with a hose and a manometer before the DPF on the test pipe. The measured exhaust back pressure may not exceed **300 mbar** in any rpm range when testdriving the vehicle – already under operating temperature. Please also refer to the 4th issue of our Technical Guide for additional information. We also offer relevant equipment for the measurement, our reference: **MESS01**.

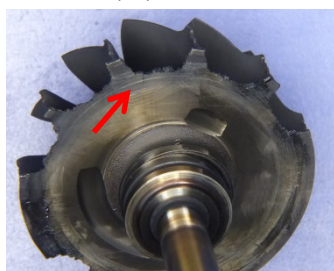
turbine wheel –
grazed on housing

compressor wheel –
grazed on housing

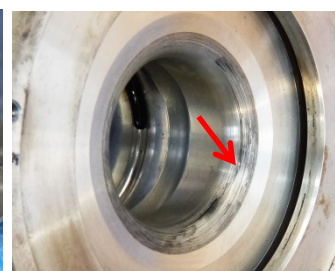
abraded compressor
housing
