### Noise and loss of power due to material breakouts on turbocharger components

**Vehicle Manufacturer:** Mercedes

**Vehicle:** Sprinter 213, 215, 313, 315, 513, 515 CDI

**BTS reference:** T914374, T914391      **BTS-Service-Set-Nr:** T981444, T981445

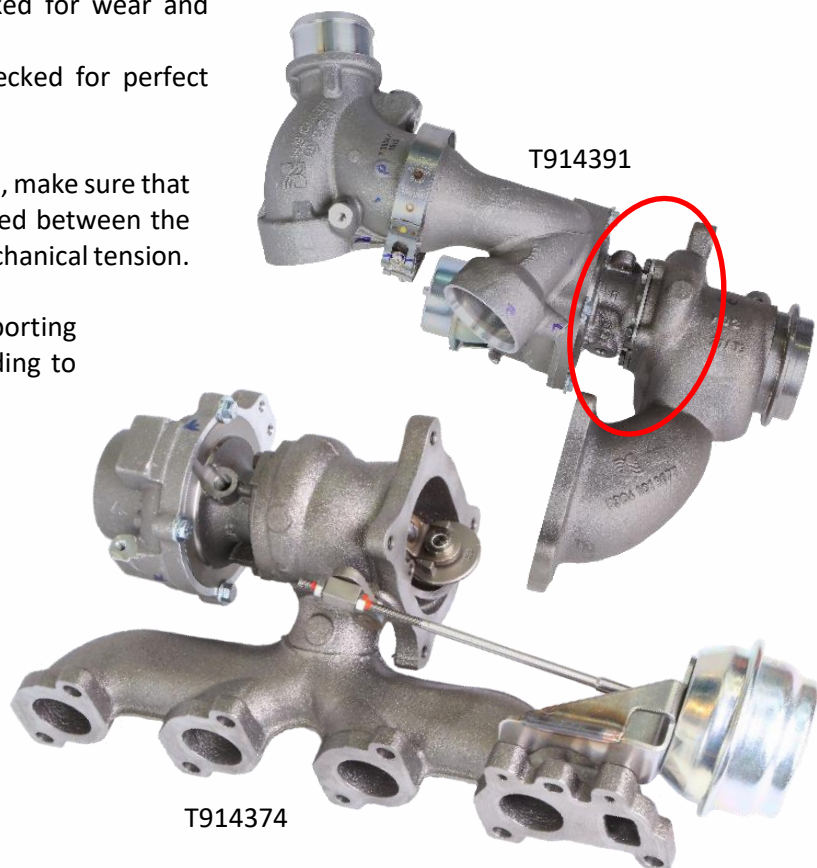
There are repeated instances of damage to these turbochargers, which ends with an outbreak of castings between the bearing housing and turbine housing of the large low-pressure supercharger T914391.

The cause is a defective two-mass flywheel. In cooperation of knocked-out engine mounts (especially in vehicles in the package distribution service), enormous vibrations act on the assemblies of the two-stage supercharging. Missing or incorrectly installed support elements to the engine block also contribute to the overloading of the components.

The engine mounts should be checked for wear and lowering and replaced if necessary.

The dual mass flywheel is to be checked for perfect function. If in doubt, renew this.

When installing the two turbochargers, make sure that the charge pressure pipes are mounted between the two compressor housings without mechanical tension.

Proper installation of all supporting elements must be carried out according to the manufacturer's instructions.

When installing the boost pressure hose between the compressor and the intercooler, attention must also be paid to the absence of mechanical stress. Hardened boost hoses are to be renewed.
