BULLETIN 0002

Ford 2.0 diesel - FWP 1948 & FWP 2063

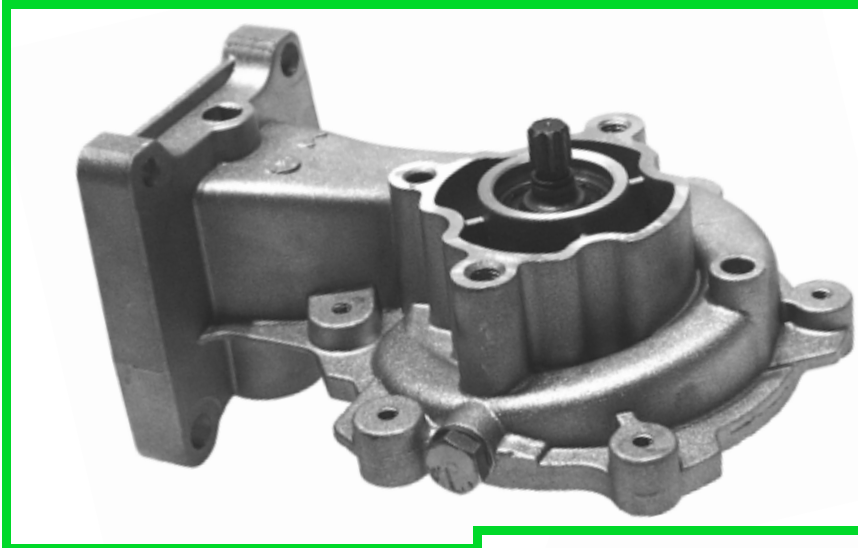
Examination of the condition of the splined drive from the power steering pump **MUST** be made prior to the installation of the new Water Pump. If there is any evidence of wear the power steering pump **MUST** be replaced.

Remove all traces of old grease from the pump drive shaft splines, remove and discard the old 'O'ring seal.

Install the new 'O' ring and apply the contents from the grease sachet to the power steering pump drive splines before fitting the new Water Pump
