TSB-DE01

Clutch Release Mechanism Problems

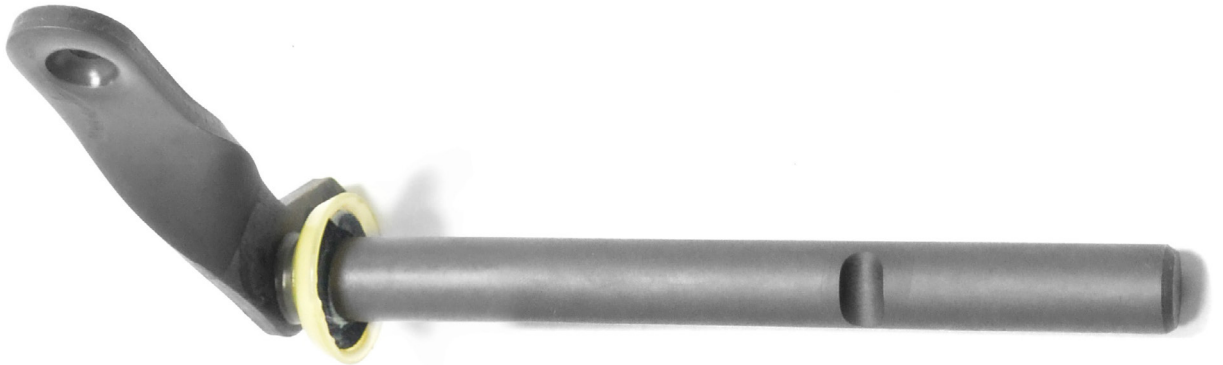
The gearbox input shaft sleeve, clutch release fork and clutch release shaft bushes should be carefully inspected for wear. A worn input shaft sleeve will prevent the release bearing from moving freely, causing hard clutch pedal action, vibration and slipping problems. A worn clutch release fork will cause misalignment of the release bearing on the gearbox input shaft sleeve and cover assembly diaphragm fingers, resulting in clutch non-release and vibration problems. Worn release shaft bushes will cause excessive play in the release shaft resulting in clutch non-release, hard pedal action, slipping and vibration problems. A distorted or worn clutch release fork securing bolt will allow the release fork to rotate on the release shaft, resulting in clutch non-release problems.

The cross shaft in these vehicles will often experience fractures in the welds between the arm and the cross shaft which causes the slave cylinder to bottom out on the circlip after installation. These fractures cannot be seen but can be identified by inspecting the angle of the arm to the cut out in the cross shaft. If the cross shaft is damaged, as shown below, a new cross shaft must be used in the vehicle. These cross shafts are commonly available from Australian Clutch Services.

Worn/Damaged
