febi 175368

Toyota Land Cruiser (URJ20*),
 Sequoia (UPK60, USK6*),
 Tundra (UPK5*, USK5*),
 Lexus LX460, LX570 (URJ2)

Oil Filter Housing Cap

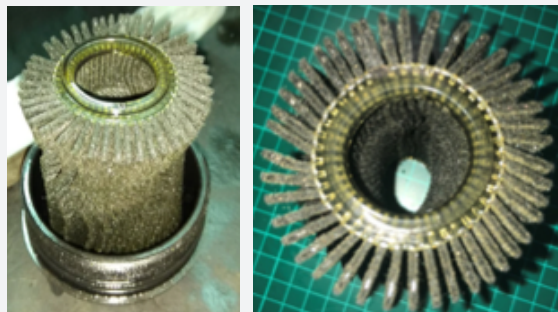
The low oil pressure lamp is illuminated and the vehicle loses power, as well as becoming noisier in operation.

It is possible for the central perforated support tube to become detached from the cap when removing the old oil filter. If this goes unnoticed it will result in the oil filter collapsing inwardly - reducing the oil flow to the engine and potentially causing catastrophic engine damage.

Before fitting a new oil filter element, check to make sure that the perforated support tube is securely attached to the oil filter housing cap. If it is missing or loose, replace the cap. Remember to lubricate the O-ring seal with clean engine oil before fitment and tighten the cap to 25Nm.
