TECHNICAL REPORT

Subaru BRZ and Toyota GT86
upgrading the oil pan sealing

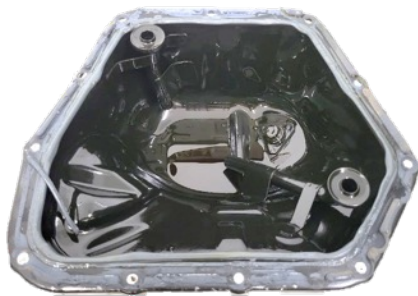
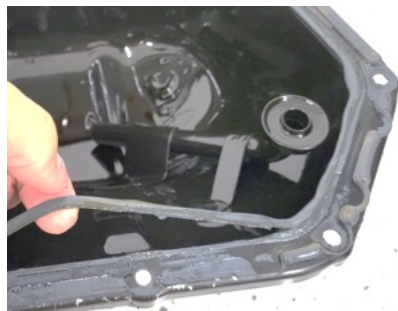
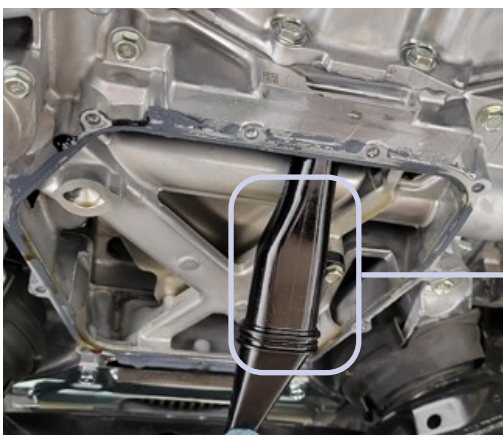
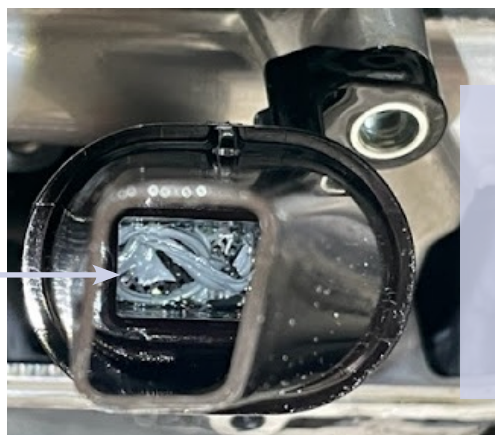
One of the main reasons for clogging is the **silicone that is used** in the crankcase for sealing. There have been many reports from customers indicating that after opening up oil pressure problems and removing the crankcase to check the suction filter, traces of the excess silicone bead have been found on the inside of the crankcase.

In these pictures you can see how **the excess silicone** in the crankcase has come loose and has been sucked into the lubrication system, clogging the pre-filter.

The problems observed due to excess sealant in the crankcase can be mitigated by applying a **smaller amount of sealant** (3 mm thick) to prevent these excesses from entering the interior.

Despite this solution, AJUSA offers an **alternative sealing** solution for this crankcase with a solid gasket, made of 1.2mm thick aramid fibre, which avoids 100% the problem of clogging the lubrication system.
