# TECHNICAL REPORT

Cylinder head cover gasket  
assembly 11080300 on BMW  
engines

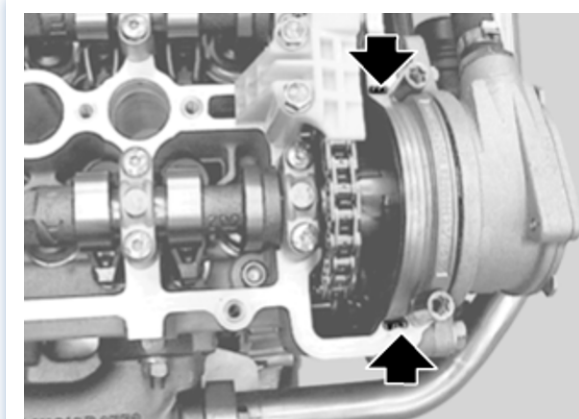
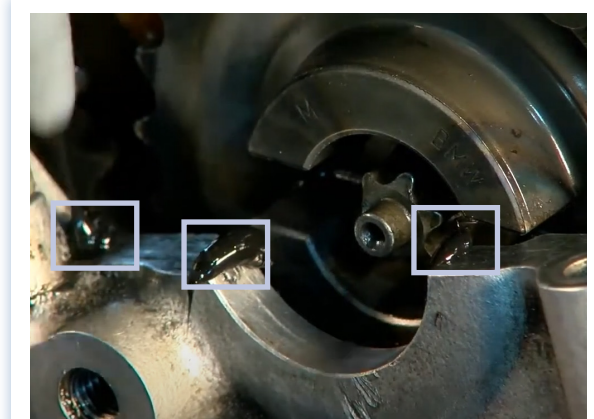
**01** | Absence of sealant in areas where its use is recommended by the workshop manual.

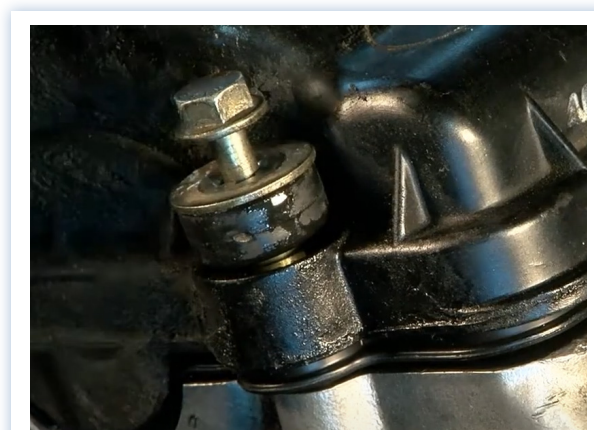
**02** | Poor condition of **bolts and/or rubber** plugs. As stated in the workshop manual, the condition of the cover bolts must be taken into account. These bolts are fitted with a rubber stopper which, if in poor condition, will not be able to achieve adequate compression on the cover and the gasket, which could **lead to oil leaks**. It is advisable to replace them to prevent oil leaks.

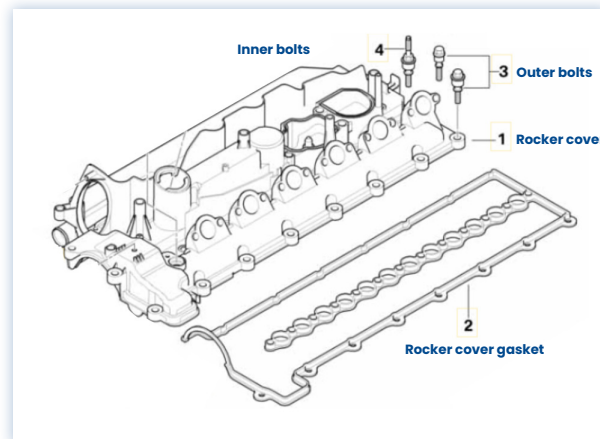
**03** | Incorrect tightening torque. In the specific case of this rocker cover, there are two types of bolts of different metrics, each type with a specific tightening torque:

Inner bolts: Metric 6 (M6), tightening torque 10 Nm.

Outer bolts: Metric 7 (M7), tightening torque 15 Nm.

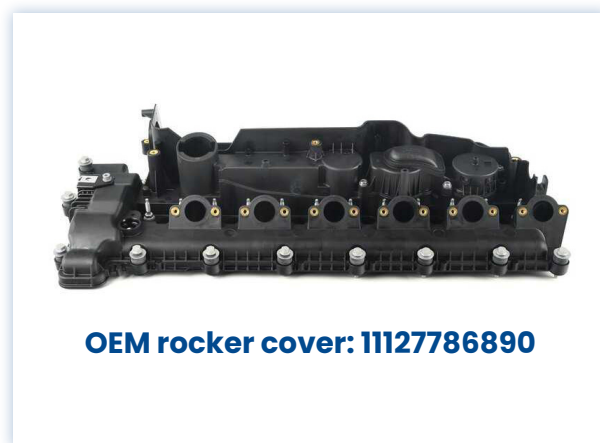
**04** | It is sometimes recommended to replace the rocker cover, as it is made of plastic and can often become deformed, causing the gasket not to seat properly and subsequently leading to oil leakage.
