# SWAG 33 10 3603, 33 10 3573

To fit:  
various Audi and Volkswagen models  
with V6 TDI engine

## Intake manifold with swirl flap actuator and gasket

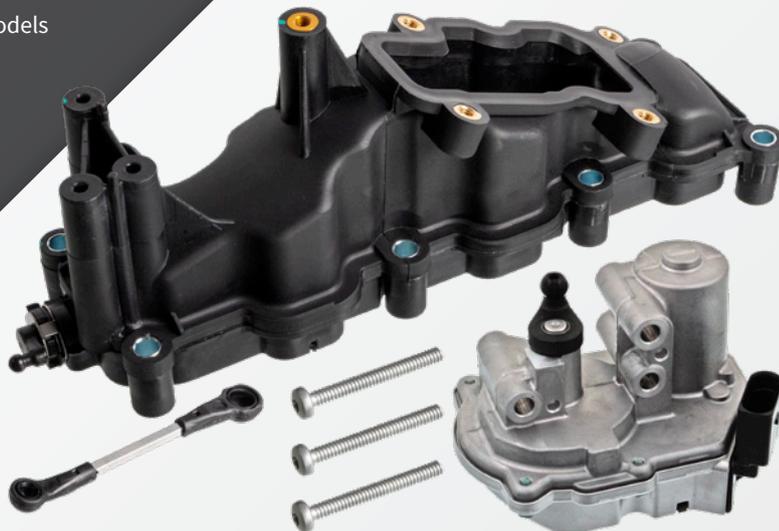
The engine performance and drivability is poor, and the engine warning lamp is illuminated.

Excess carbon build-up in the inlet manifold prevents the swirl flaps from opening or closing completely. This puts unnecessary strain on the linkage and actuator, leading to a broken or worn linkage. As a result, the actuator operates out of its designed tolerances and the following fault code is logged in the engine control unit: P2015 - intake manifold flap position/signal improbable.

For this repair, SWAG provides a combined kit containing the inlet manifold, gasket and swirl flap adjustment motor and linkage for each manifold. Following the successful completion of the replacement, the swirl flap system has a 'learning' procedure take place - for this, a suitable diagnostic tool is required.
