SWAG 33 10 4277

BMW X3 (E83), X5 (E53, E70), X6 (E71, E72)

Adjustment motor for transfer case

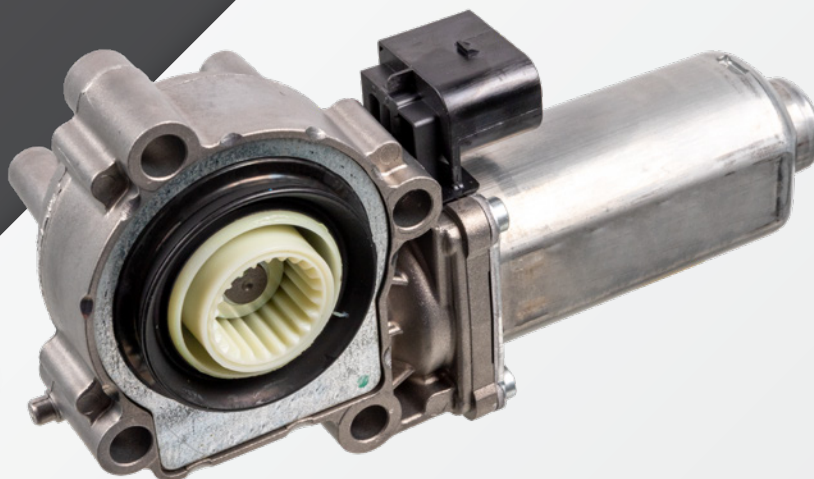
A clicking noise can be heard from underneath the vehicle - around the area of the transfer case - when switching the ignition on or off.

The engine is jerky in operation when accelerating in lower gears.

The ABS, 4x4 and brake system warning lamps are illuminated - related to the symptoms listed above. These possible fault codes may be stored in the transfer case control unit:

- 539E Control motor or transfer case faulty.
- 5463 Transfer case mechanical fault.

Wear of the transfer case adjustment motor drive gear - often caused by an excessive variance of tyre tread depths between the front and the rear axle.

To check that all systems are fully functional, carry out a full system scan of all fault codes using a suitable diagnostic tool.

Check the transfer case adjustment motor operation and replace as necessary, then clear/reset all fault codes after the repair.

Check the tread depths of all the tyres and replace as necessary.
