## TSB-162

### Clutch Fork Vibration Absorbers

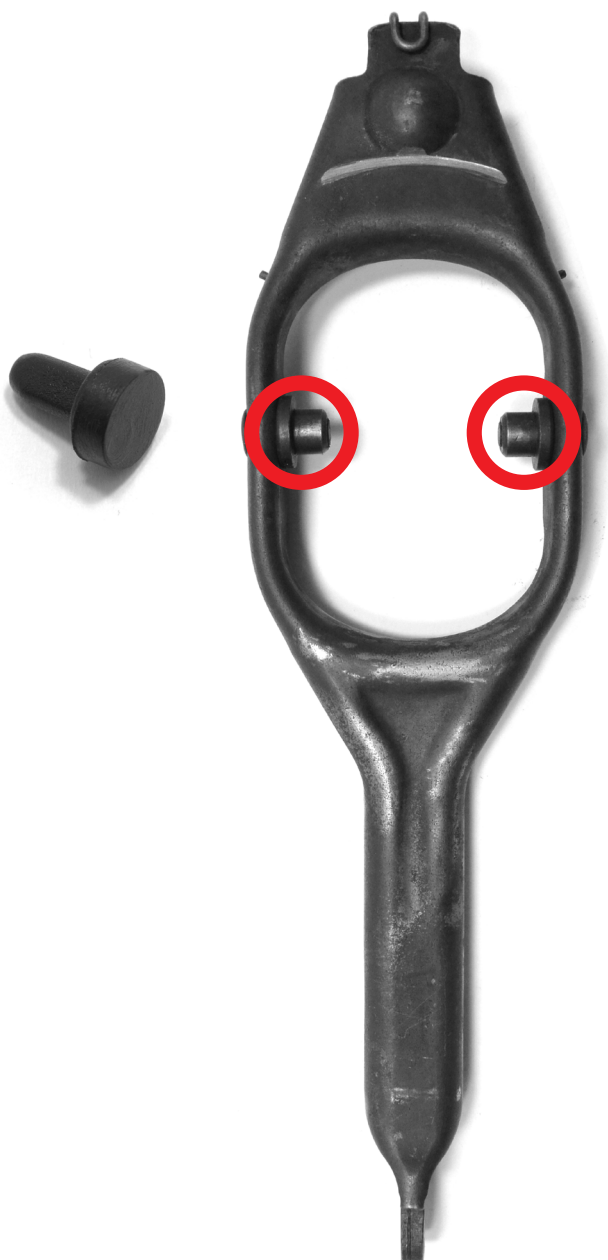
The rubber tips on the clutch fork of various Holden Commodore vehicles often perish over time causing the clutch fork to drop in the window of the bellhousing which will cause a rattle and misalignment of the release mechanism. This is most apparent when a new clutch kit is installed in the vehicle.

It is therefore vital to ensure that the fork rubbers are in good condition and if the bearing is not a tight fit in the fork, then the rubbers must be replaced. (Part Number: GM-ABS01 x2 required)
