TSB - MB06

Solid Flywheel Conversion kit for Mercedes Sprinter

Relates to kits KMB24507 and KMB24607

Vibration Problems After Fitment

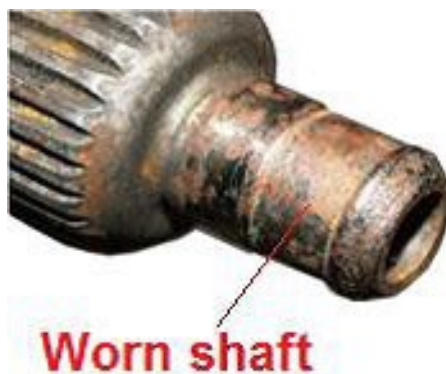
Worn Gearbox Pilot Bearing Shaft/Bearings

When fitting a SMF solid flywheel conversion kit, it is important to check both wear on the pilot bearing shaft (Refer below photo) and excessive movement of the shaft which would indicate worn bearings. Any wear to either the bearings or the shaft can cause vibration when the speed of rotation matches the natural, or resonant, frequency of the shaft.

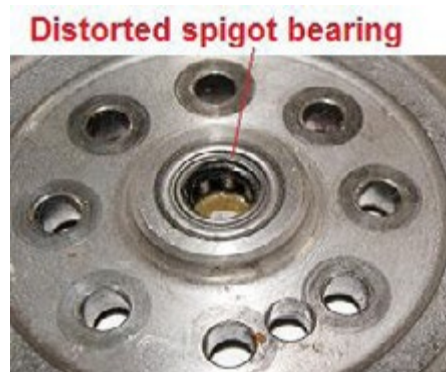
Spigot Bearing Damage During Fitment

When refitting the gearbox, care needs to be taken to ensure that the pre-fitted flywheel spigot bearing is not damaged (Refer below photo).

Failure to do this can result in bearing damage which prevents adequate input shaft support and leads to wear and vibration.

Always ensure the gearbox is fully supported and inserted centrally.
