TSB - N103

Clutch Problems Caused by Worn Release Bearing Retainer Clips

Applies to all ClutchPro Nissan kits

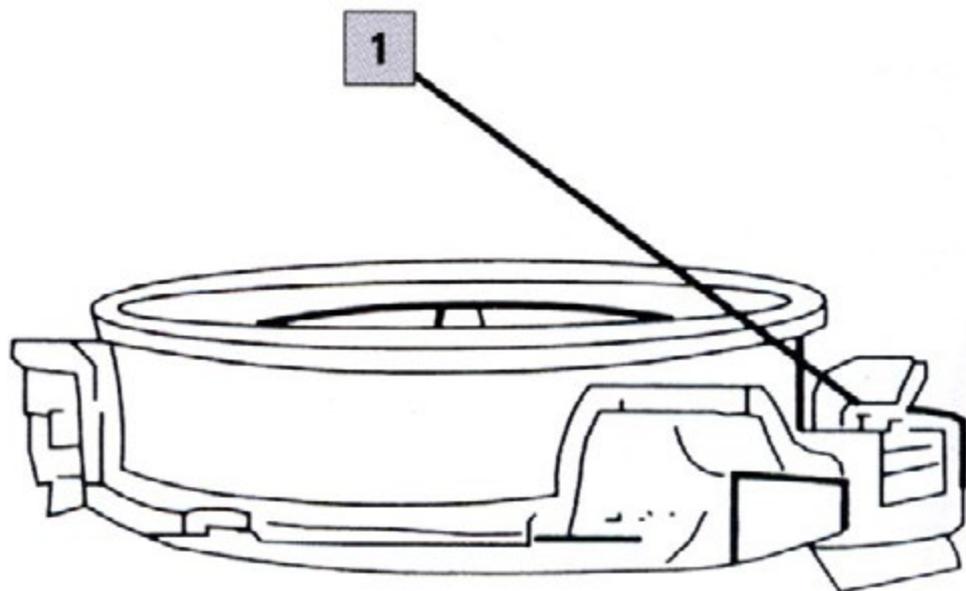
The retainer clips are generally found to be severely worn due to constant contact with the clutch release fork and are seldom replaced with new parts when a new clutch is fitted. Worn clips may break while in operation in the vehicle, causing the release bearing to separate from the clutch release fork. The loose release bearing will then rotate on the gearbox input shaft sleeve and jam between the clutch release fork mounting lugs, preventing the clutch from operating.

In some cases the loose clutch release fork can come into contact with the cover assembly diaphragm, causing severe damage to the diaphragm fingers and immediate clutch failure.

The release bearing retainer clip and its location are indicated by point 1 on the sketch below.

When fitting a clutch to Nissan Pulsar/EXA, Maxima and 2.5/2.7 Diesel vehicles the spring steel release bearing retainer clips on the clutch release fork should be replaced with new parts in order to prevent clutch problems caused by failure of the clips in the vehicle.

When fitting a clutch to these vehicles the retainer clips should be carefully inspected for wear or damage and replaced if necessary before fitting the release bearing in order to prevent future clutch problems.
