CLUTCH TECHNICAL GUIDE

TBC15

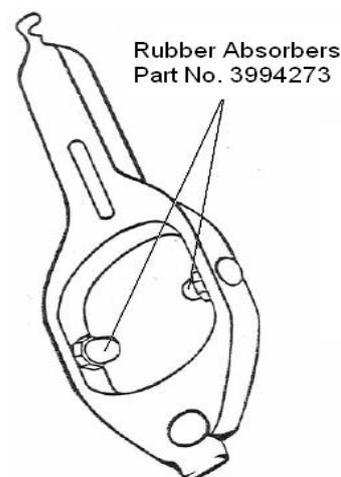
1. The clutch fork should have two rubber absorbers fitted on the lugs that contact the release bearing. (The diagram on the right indicates the intended location of the rubber absorbers). In all cases we have seen, these rubber absorbers are missing, allowing the bearing to rattle on the fork. Fitting these absorbers will help to stop the bearing rattling. The genuine Holden part number for this part is 3994273.
