CLUTCH TECHNICAL GUIDE

TBC84

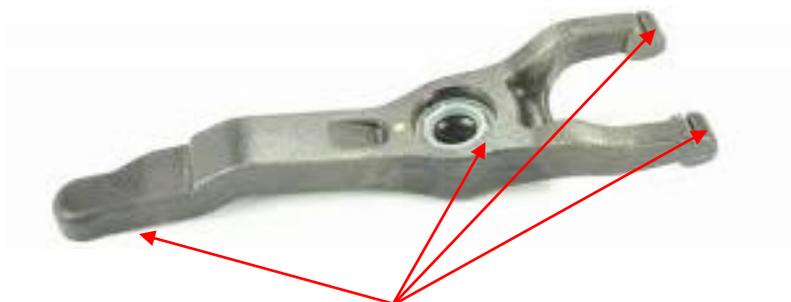
In some applications, there is insufficient or no lubrication on the clutch release fork and pivot ball, causing a noise to come from the bellhousing.

Lubricate these areas.

1. When the gearbox is apart, the clutch release fork can be removed and thoroughly cleaned, using a degreaser or alike.
2. Lubricate the areas pointed out in the image of the clutch pivot fork below.
3. Check the pivot ball for wear. If there is any evidence of wear, the pivot fork will need to be replaced.
4. Lubricate the bearing and check that it slides satisfactorily on the spigot shaft.
5. Refit the clutch release fork, making sure the clip has been located and the fork sits on the pivot ball.
6. Fit the new clutch bearing to the release fork, making sure the bearing is secured correctly and the fork is in the correct position.
