TECHNICAL**BULLETIN****TECH
MATE**

Bulletin Ref: TB21a

Mercedes A Class**AAL1118**

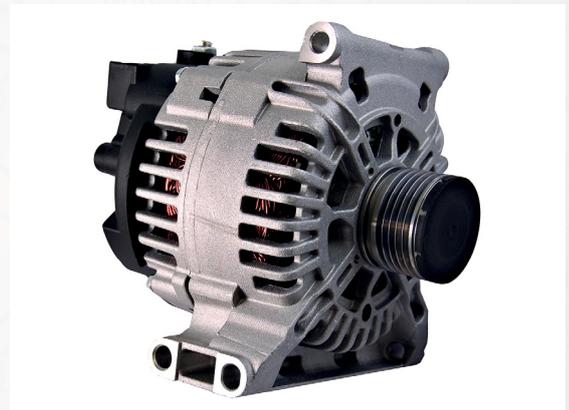
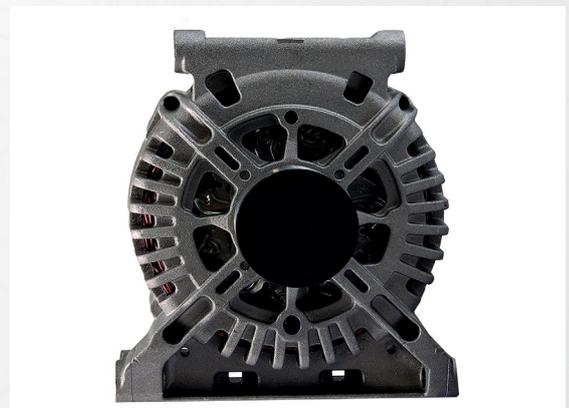
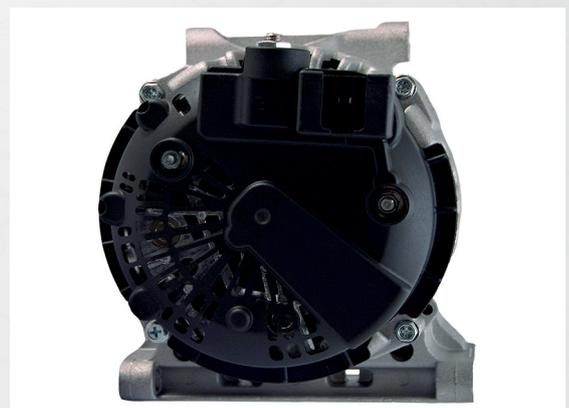
A charging issue on the Mercedes A Class CDI is often due to a fault with the ECU or 'SAM' control unit.

Both of these control units control and monitor the alternator charge output.
