Bulletin Ref: TB19a

## Ford Alternator Broken Wire

**AAL1121**

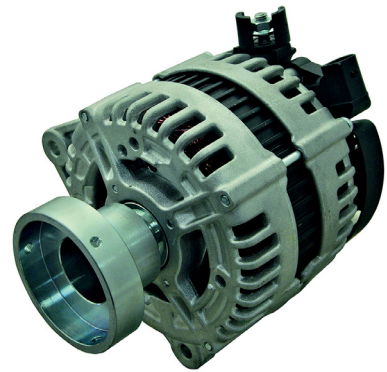
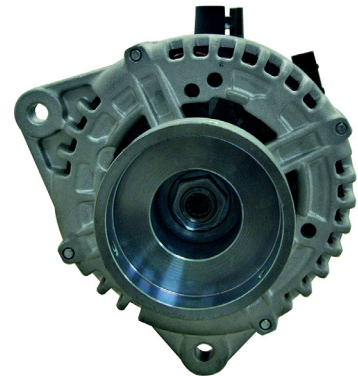
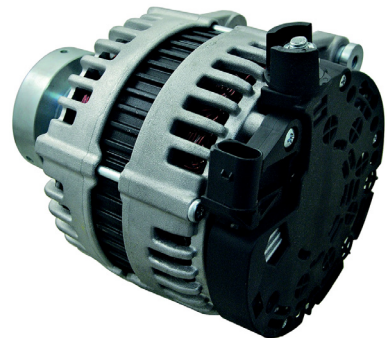
1. One Amp fuse is sometimes defective, this can be found in the main fuse box in the engine bay.
2. The wiring harness from factory is too tight resulting in broken wires in the harness, the wires are mostly broken under headlight.
3. Corrosion inside the multi connector on the rear of the unit is also common.
