Bulletin Ref: TB19a

Ford Alternator Broken Wire**AAL1424**

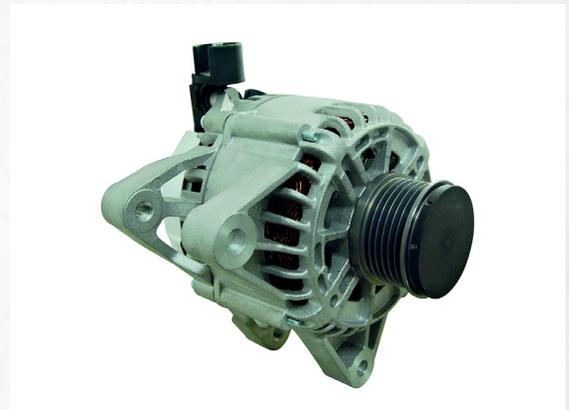
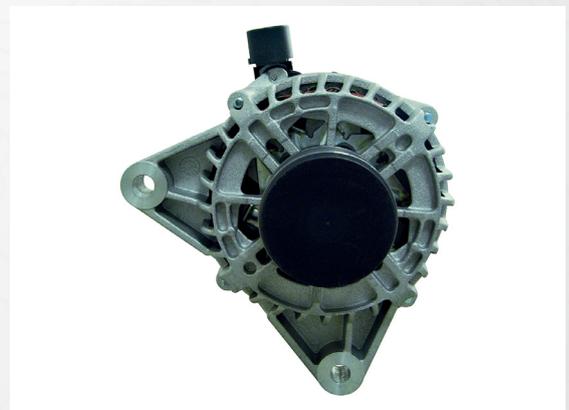
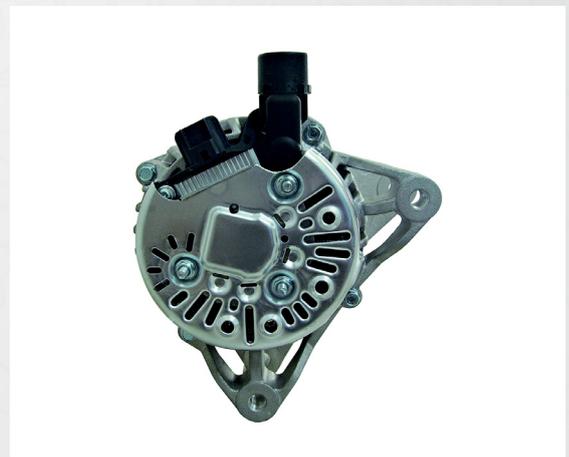
1. One Amp fuse is sometimes defective, this can be found in the main fuse box in the engine bay.
2. The wiring harness from factory is too tight resulting in broken wires in the harness, the wires are mostly broken under headlight.
3. Corrosion inside the multi connector on the rear of the unit is also common.
