**TECH
MATE**

Bulletin Ref: TB5a

AAL1702

Common issues for charging problems:

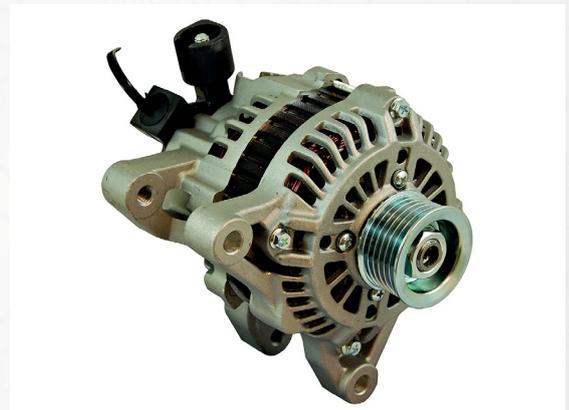
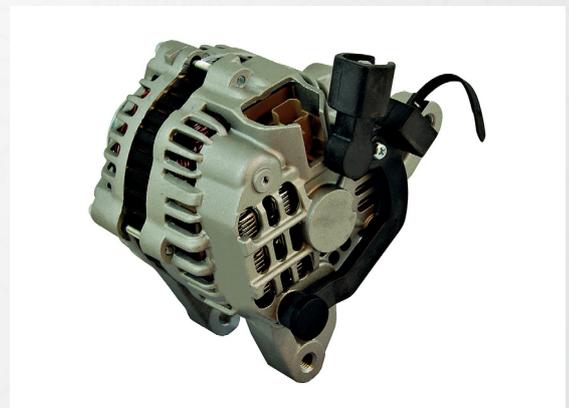
1. This unit is controlled by the vehicles ECU which can be defective.
2. A corroded B+ cable from alternator to the battery is also common issue.
