Bulletin Ref: TB19a

Ford Broken Wire

AAL1841

Possible issues relating to charging problems:

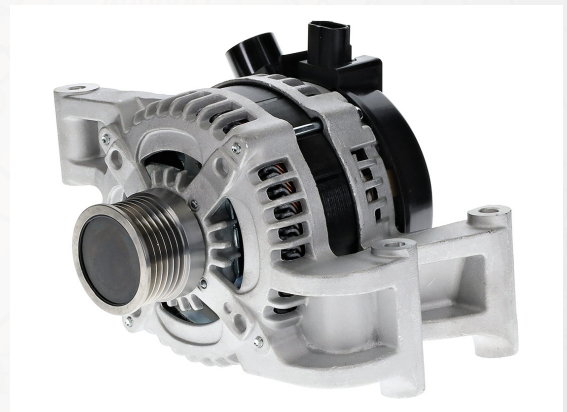
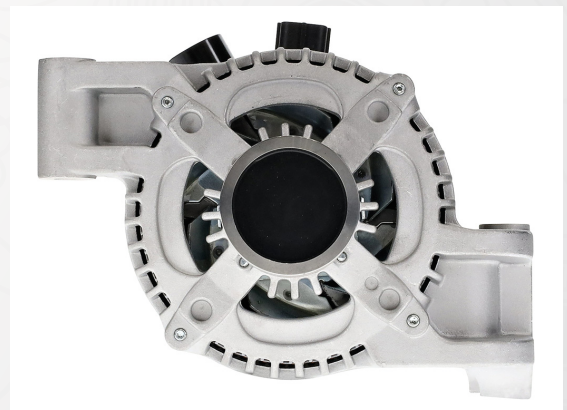
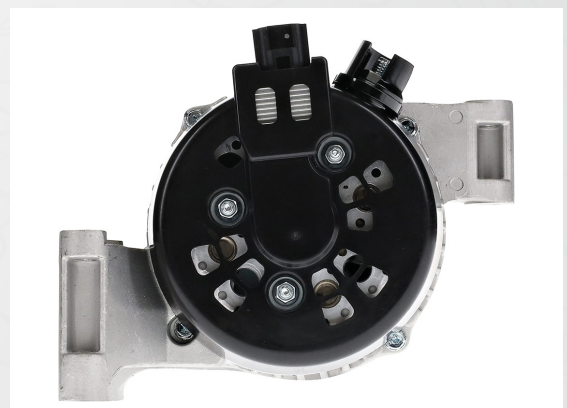
1. One Amp fuse is sometimes defective, this can be found in the main fuse box in the engine bay
2. The wiring harness from factory is too tight resulting in broken wires in the harness, the wires are mostly broken under headlight
3. Corrosion inside the multi connector on the rear of the unit is also common.
