CLUTCH TECHNICAL GUIDE

TBC15

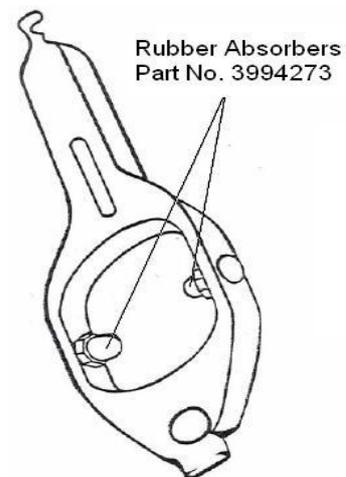
1. The clutch fork should have two rubber absorbers fitted on the lugs that contact the release bearing. (The diagram on the right indicates the intended location of the rubber absorbers).

In all cases we have seen, these rubber absorbers are missing, allowing the bearing to rattle on the fork. Fitting these absorbers will help to stop the bearing rattling. The genuine Holden part number for this part is 3994273.
