## TECHNICAL BULLETIN

### NAL1045 - Ford Alternator Broken Wire

Bulletin Ref: TB19n

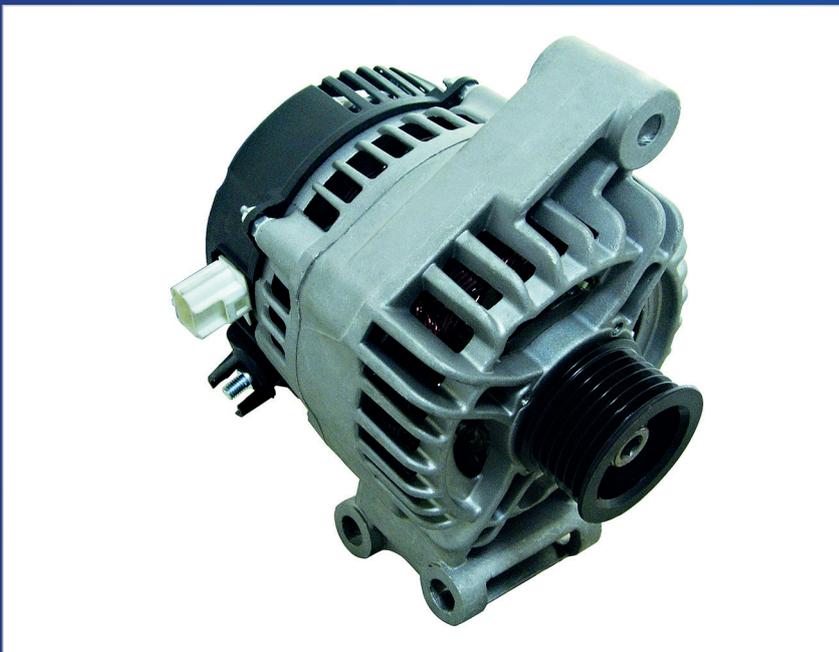
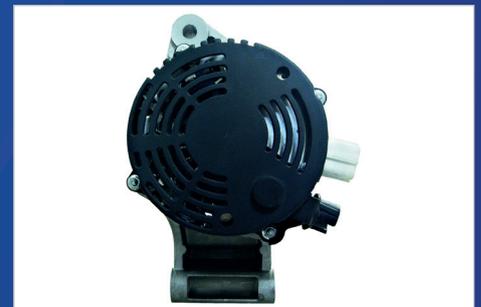
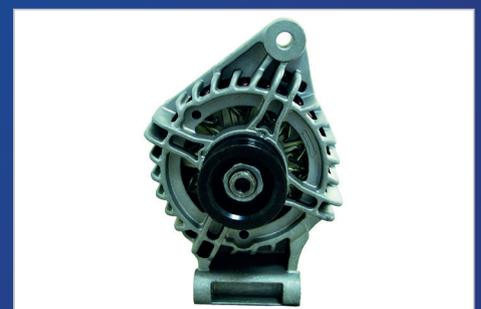
1. One Amp fuse is sometimes defective, this can be found in the main fuse box in the engine bay.
2. The wiring harness from factory is too tight resulting in broken wires in the harness, the wires are mostly broken under headlight.
3. Corrosion inside the multi connector on the rear of the unit is also common.
