TECHNICAL BULLETIN

NAL1424 - Ford Alternator Broken Wire

Bulletin Ref: TB19n

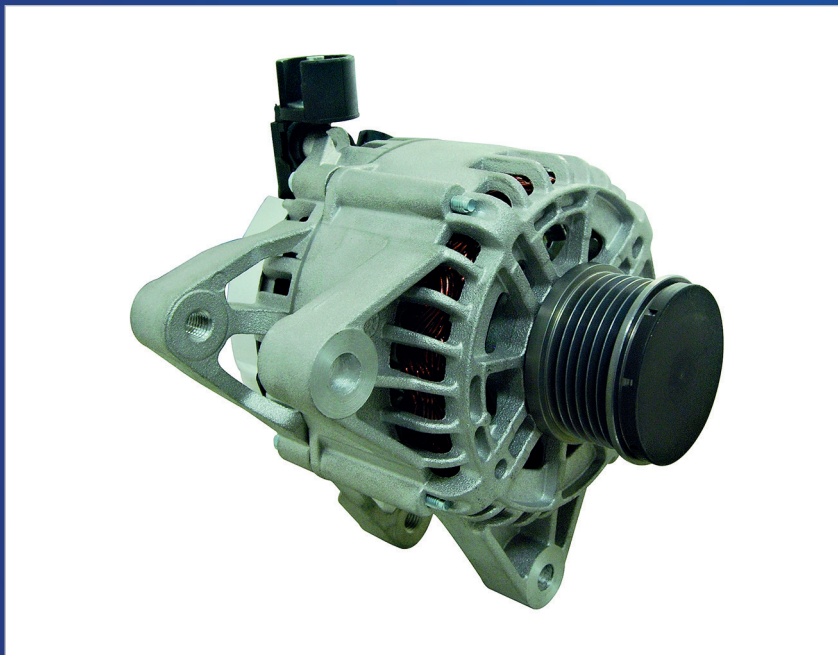
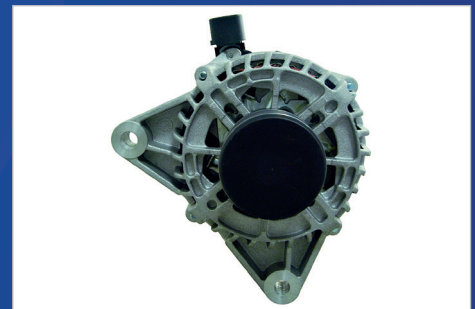
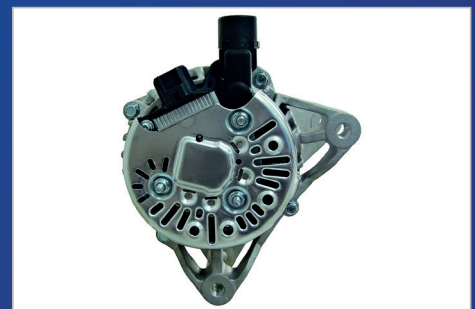
1. One Amp fuse is sometimes defective, this can be found in the main fuse box in the engine bay.
2. The wiring harness from factory is too tight resulting in broken wires in the harness, the wires are mostly broken under headlight.
3. Corrosion inside the multi connector on the rear of the unit is also common.
