TECHNICAL BULLETIN

NAL1692 - Ford Broken Wire

Bulletin Ref: TB19n

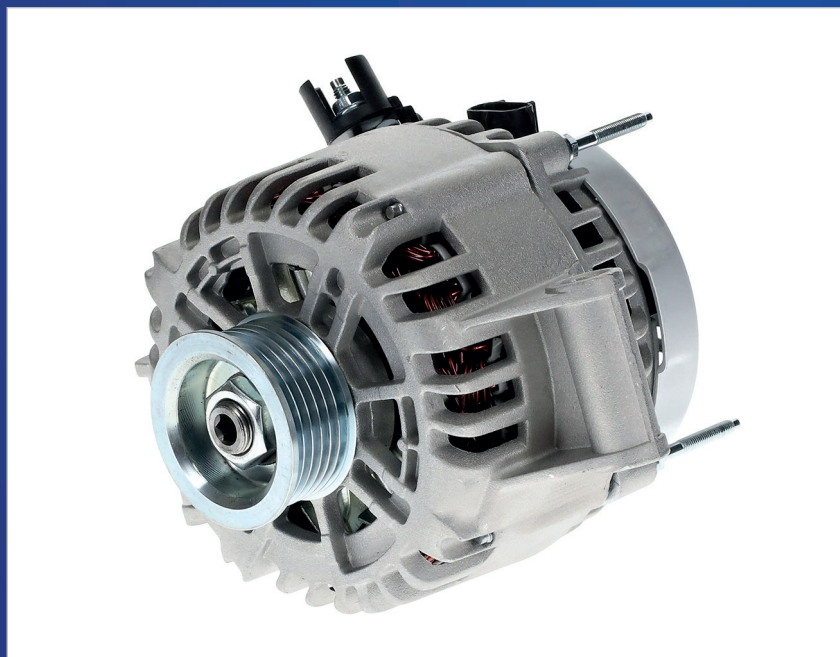
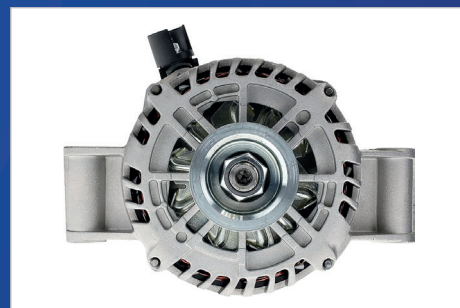
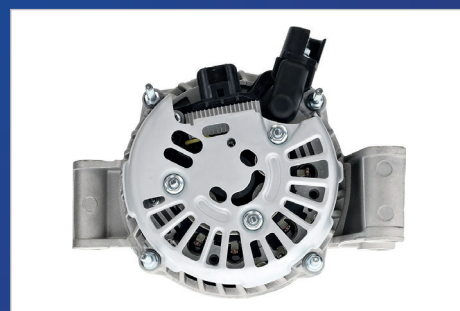
Possible issues relating to charging problems:

1. One Amp fuse is sometimes defective, this can be found in the main fuse box in the engine bay
2. The wiring harness from factory is too tight resulting in broken wires in the harness, the wires are mostly broken under headlight
3. Corrosion inside the multi connector on the rear of the unit is also common.
