TECHNICAL BULLETIN

NAL1797 - Ford Alternator Broken Wire

Bulletin Ref: TB19n

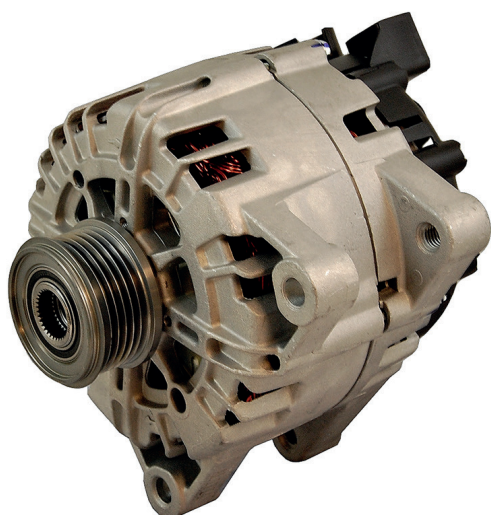
Possible issues relating to charging problems:

1. One Amp fuse is sometimes defective, this can be found in the main fuse box in the engine bay.
2. The wiring harness from factory is too tight resulting in broken wires in the harness, the wires are mostly broken under headlight.
3. Corrosion inside the multi connector on the rear of the unit is also common.
