## TECHNICAL BULLETIN

### NAL1867 - 80amp Korean Fuse

Bulletin Ref: TB11n

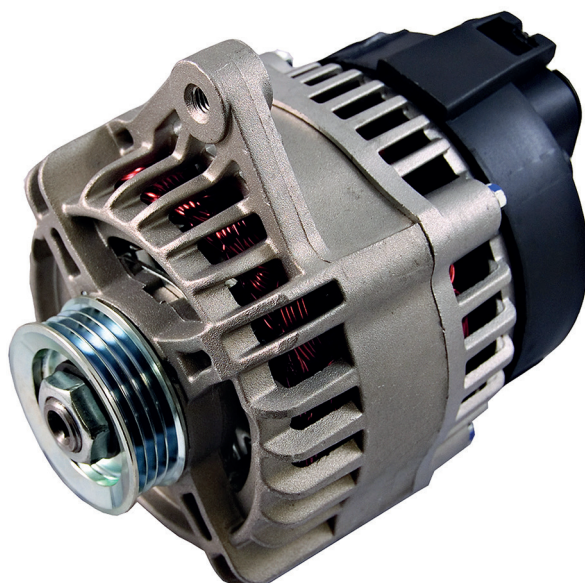
Fig 1.

Before fitting check the 80a PAL type fuse as this fuse can blow causing no charge. (Fig 1.)

Also check for corrosion around and underneath the fuse connections which is common.
