NSM1319

Bulletin Ref: TB27n

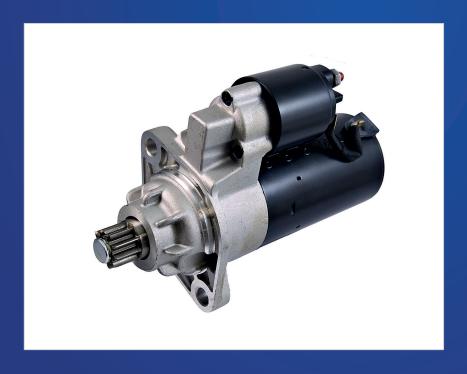
The ignition switch can be defective causing the starter motor to either keep running resulting in the starter motor burning out prematurely or to not turn at all.

Please double check before ordering and fitting.
