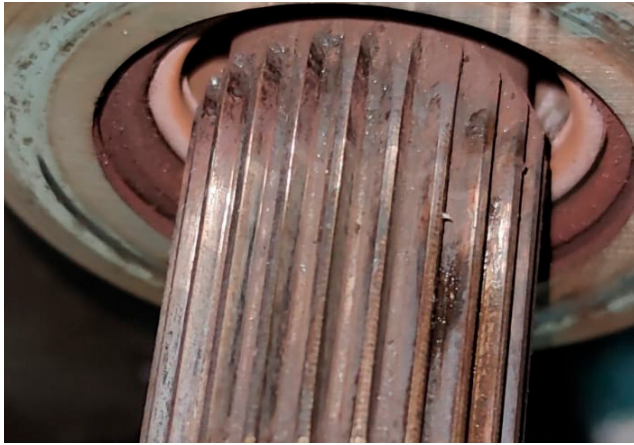
Image 3: Gearbox input shaft with increased spline wear

- Use new clutch mechanism fixing bolts.
- Follow the correct tightening order and tightening torque of the clutch bolts to the flywheel.
- Lubricate the gearbox input shaft splines with a small amount of suitable lubricant.

- Distribute the grease by sliding the clutch disc on the input shaft 5–6 times, then wipe off the excess grease using a clean cloth.
- Carefully remove the clutch diaphragm spring retainer after installing the clutch to the flywheel.

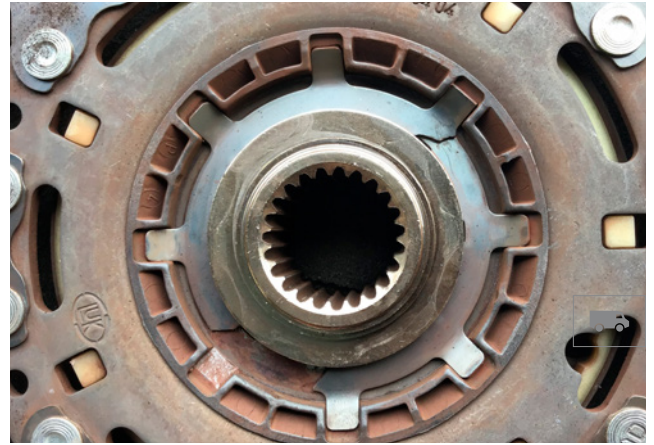
Image 4: Wear of the clutch disc splines and a broken ring-shaped leaf spring

- Check the wear of other components adjacent to the clutch (flywheel, seals, release system, etc.).
- The ring-shaped leaf spring can also be damaged if the axial play of the crankshaft main bearings is out of tolerance (e.g., axial play > 0.25 mm).

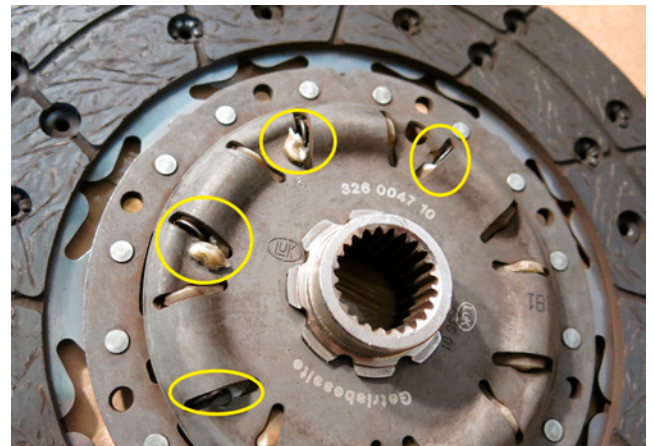
Image 5: Damage to the plastic disc torsional damper guides
