LuK Service Info

Grinding noises from the clutch

Clutch and accessory release lever not compatible

Model: Bus Tourismo

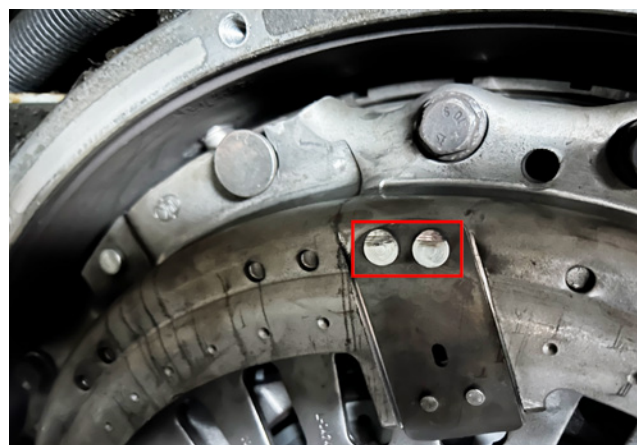
Figure 1: Material loss on the rivets due to incorrect release lever

In some cases, grinding noises from the bell housing may occur after replacing the clutch on the vehicle model specified above.

The cause of the complaint is insufficient clearance between the release lever and the clutch. The release lever rubs against the clutch cover and wears away material on the rivets of the adjusting unit (Figure 1).

The complaint only occurs with accessory release levers. That is why, when installing the LuK RepSets specified above, it is essential that these are only combined with the original release levers from the vehicle manufacturer.
