## LuK SERVICE INFO

# Installation features of the double clutch

## Prevention of vibrations

Make:	Ford
Models:	B-MAX Ecosport Fiesta VI Focus III
Years:	since 2010
Engines:	1.5, 1.6, 2.0
Art.-Nr.:	602 0008 00

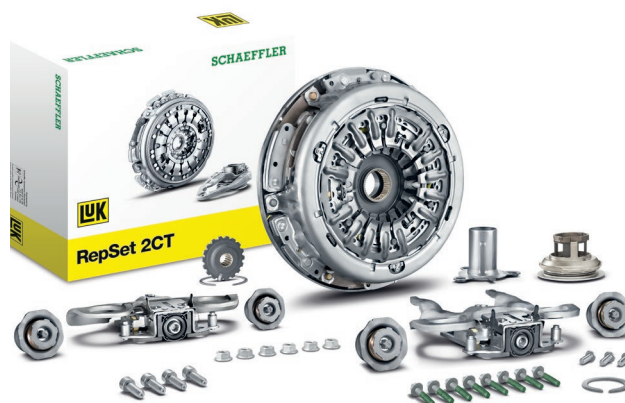
Image 1: LuK RepSet 2CT Art.-Nr. 602 0008 00

As part of our ongoing quality control it has been observed that after installing LuK RepSet 2CT repair solution Art.-Nr. 602 0008 00 (Image 1) occasionally a vibration can be detected.

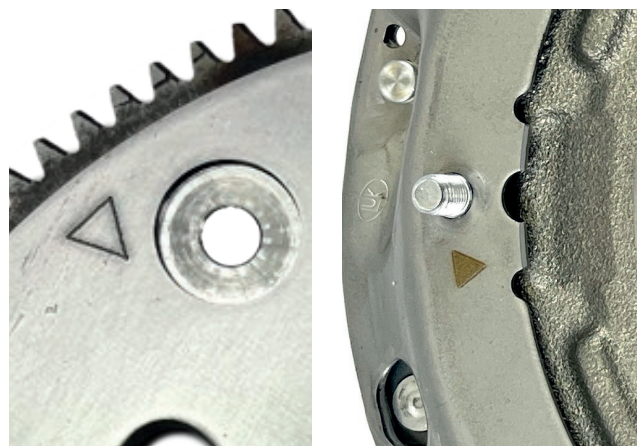
Image 2: Marks on the single-mass flywheel and the double clutch

- Correct positioning of the markings on the single-mass flywheel and double clutch module (Image 2);
- Correct tightening order of the double clutch studs to the single-mass flywheel (Image 3);
- Basic adjustment of the clutch system carried out using a suitable diagnostic tool;
- In case of re-installation of a previously used double clutch the transport fasteners must be reset.

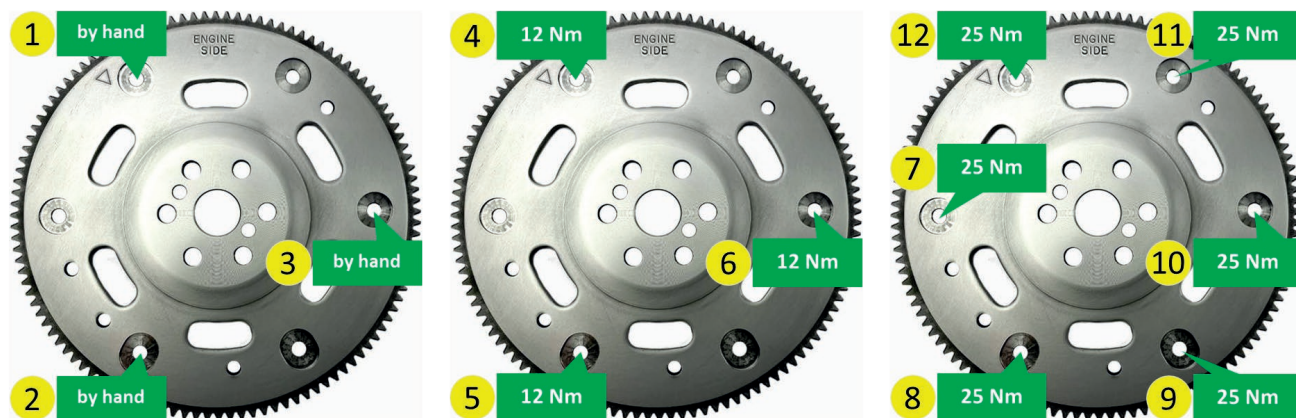
Image 3: Correct tightening order of double clutch studs to single-mass flywheel

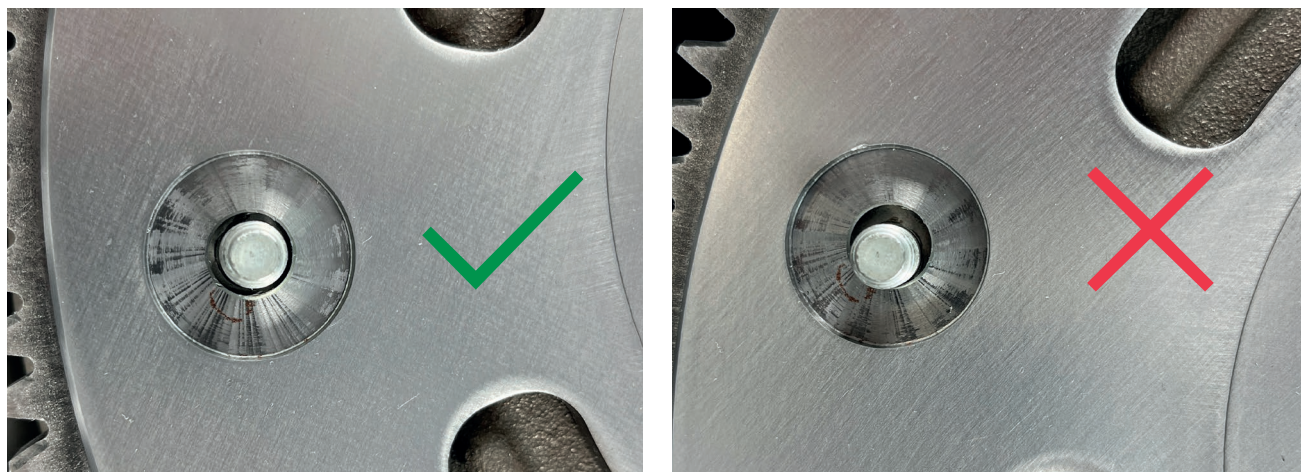
Image 4: Correct / central position (photo on the left) and incorrect / non-central position (photo on the right) of the clutch stud in the flywheel hole

In addition a positioning of the double clutch studs relative to the holes in the single-mass flywheel during tightening is also important. The diameter of the holes is larger than the diameter of the studs, for maximum balancing it is necessary to position the studs as close as possible to the center of the flywheel holes (Image 4).
