## SWAG 50 93 9304

To fit:  
various Citroen, DS, Fiat,  
Ford, Jaguar, Lancia, Land  
Rover, Mitsubishi, Opel,  
Peugeot, Toyota and  
Vauxhall models

## Water pump with gasket

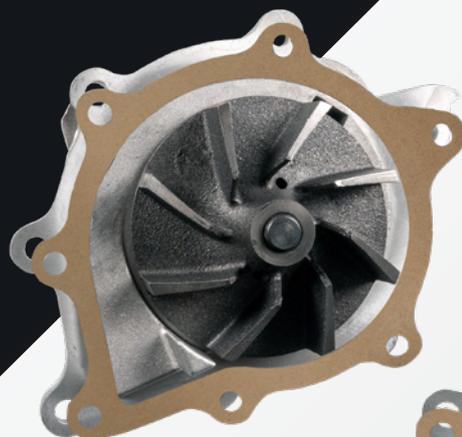
Improved SWAG water pump

Remove the auxiliary belt and timing belt. Replace the defective water pump with SWAG water pump 50 93 9304 (Fig.1), which has an improved water pump design with a metal impeller. This eliminates the potential failure caused by the water pump fitted with a plastic impeller. When replacing the faulty water pump, SWAG recommends that the timing belt kit and auxiliary drive belt is also replaced at the same time to ensure the reliability of the engine.

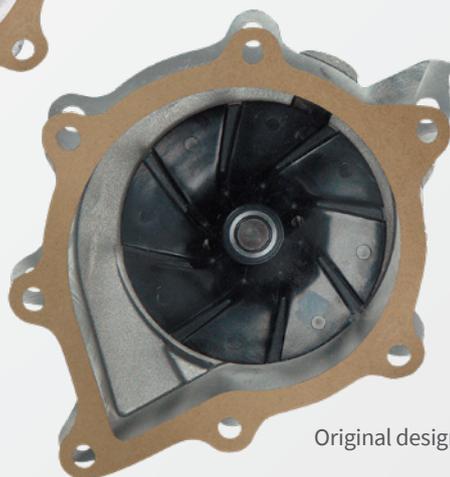
Original design

The original water pump impeller is made from plastic, which can become detached from the impeller shaft. Therefore, the water pump is turning with no effect and no coolant will flow around the cooling circuit of the engine.
