Lack of lubrication Damage to the new turbocharger Banjo bolt of the oil feed line with integrated filter

Vehicle Manufacturer: Alfa Romeo (FIAT)

Vehicle: Giulietta 1.8 TBi

Engine code: 940 A1.000

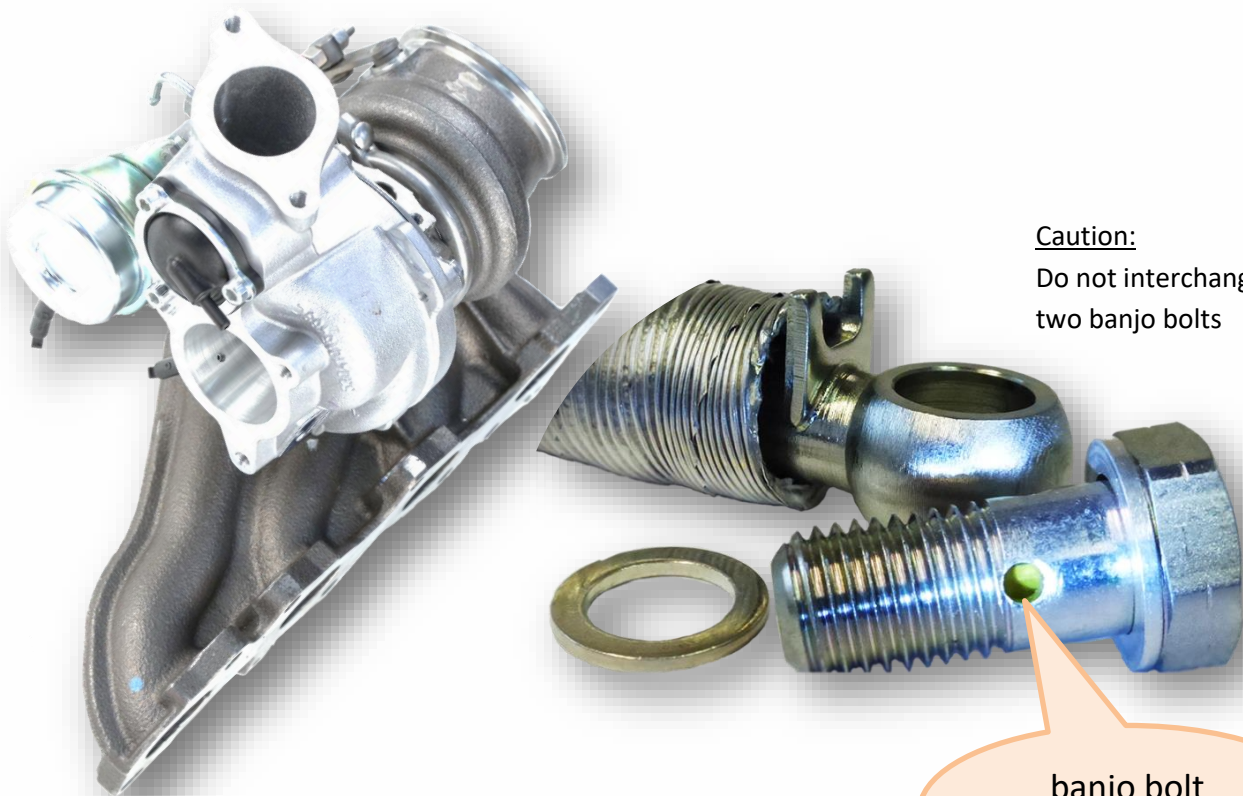
banjo bolt
including filter

In this hollow screw a fine sieve is factory installed. Impurities in the internal engine oil circuit clog this sieve in a very short time. The oil supply to the turbocharger is cut off at this point.

Do not interchange the two banjo bolts

The engine must be checked for carbon deposits in the oil pan, oil intake basket and oil filtration unit with oil cooler. After flushing the engine, the banjo bolt with filter (55224860) should be replaced again.
