### Lack of lubrication Damage to the new turbocharger Banjo bolt of the oil feed line with integrated filter

**Vehicle Manufacturer:** Alfa Romeo, FIAT, Lancia, Chrysler

**Vehicle:** Giulietta, Mito, Abarth 500, Doblo, Bavo, Linea, Punto, Delta, 1.4 T-Jet

**Engine code:** 198 A1.000, 198 A4.000, 312 A1.000

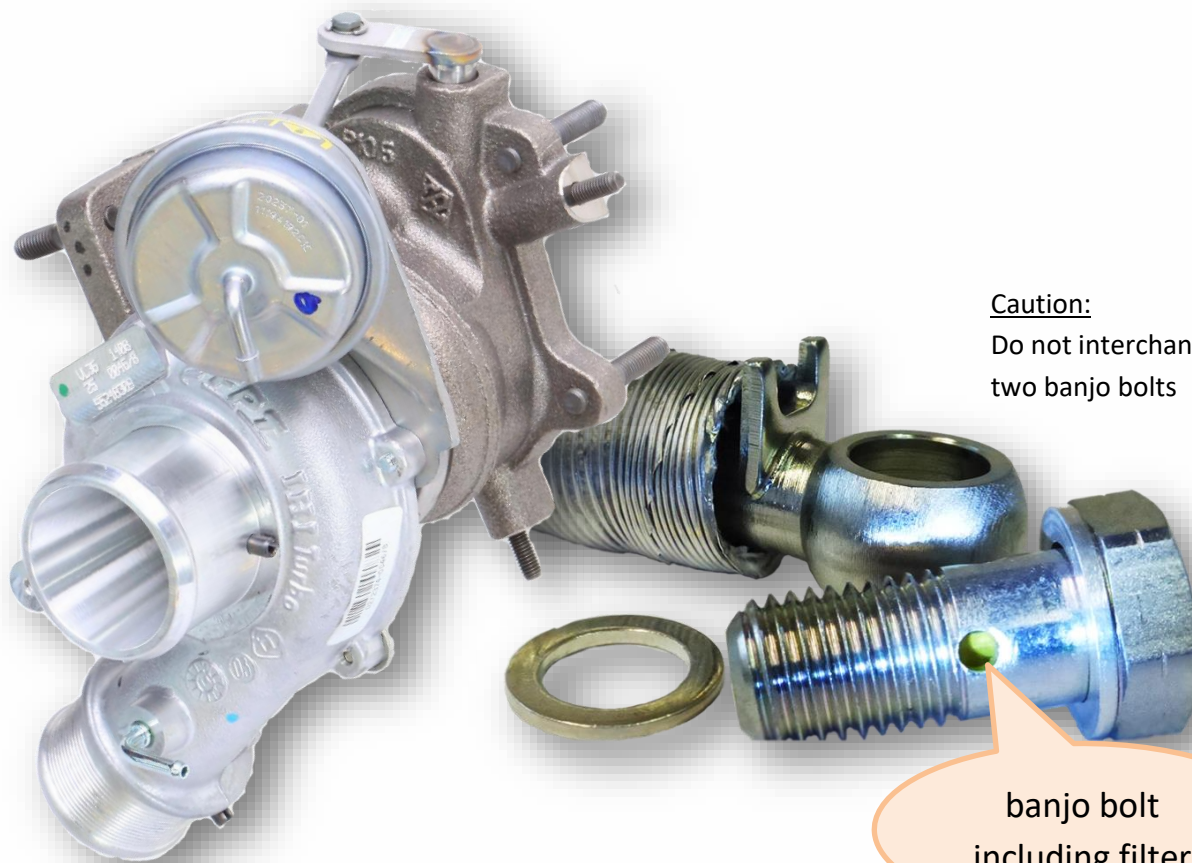
In the event of damage, there is usually a lack of lubrication damage to the bearing of the rotor shaft. To prevent the turbocharger from failing again, the banjo bolt on the engine side of the oil supply line should be examined.

In this hollow screw a fine sieve is factory installed. Impurities in the internal engine oil circuit clog this sieve in a very short time. The oil supply to the turbocharger is cut off at this point.

Do not interchange the two banjo bolts

The replacement of the oil feed pipe banjo bolt is not enough here.

The engine must be checked for carbon deposits in the oil pan, oil intake basket and oil filtration unit with oil cooler. After flushing the engine, the banjo bolt with filter (55224860) should be replaced again.
