SI-210818 Service-Information Turbocharger

Electrical actuator cannot be taught-in or already generates an error with ignition ON

Vehicle Manufacturer: AUDI, VW, SKODA, SEAT
 Vehicle: A1, A3, Golf VII, Jetta IV, Passat, Scirocco, Tiguan, Kodiaq, Rapid, Superb II, Yeti, Leon, Leon SC, Leon ST, Toledo IV, 1.4 TSFI / 1.4 TSI
 Engine code: CMBA, CPVA, CXSA, CXSB, CZCA
 Validity: This service information is valid for renewing the turbocharger with
 BTS reference: T916665 BTS-Service-Set-Nr: T981462

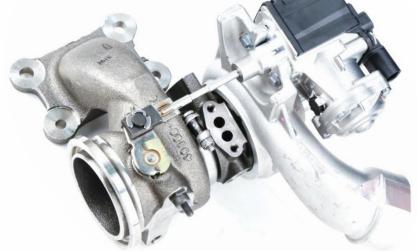
During the teach-in process, ensure that the voltage supply to the engine control unit is faultless. A weakening battery or corroded ground contacts on the engine or body can be the cause of deviations in the voltage supply. The electrical contacts of the harness-side plug must also be inspected.

Check <u>voltage supply</u> for actuator: Plug connector disconnected from actuator. Measurement on harness side. PIN 1 towards PIN 3, sowie PIN 1 towards GND = 5,0 Volt $\pm 0,2$ Check reference voltage, PIN 5 towards PIN 3 = 5,0 Volt $\pm 0,2$

Check signal voltage at actuator: (with suitable adapter cable). With ignition ON and engine running at idle speed. Signal voltage between PIN 5 and GND = 3,2 Volt $\pm 0,2$
