### Errors in boost pressure control and sticking VTG unit, caused by foreign object damage on the exhaust side

**Vehicle:** Jumper II, Boxer 2.0 BlueHDi 110 / 130 / 160

**Engine code:** AHM (DW10FUE), AHN (DW10FUD), AHP (DW10FUC)

**BTS reference:** T918442 **BTS-Service-Set-Nr:** Txxxxxxxxx

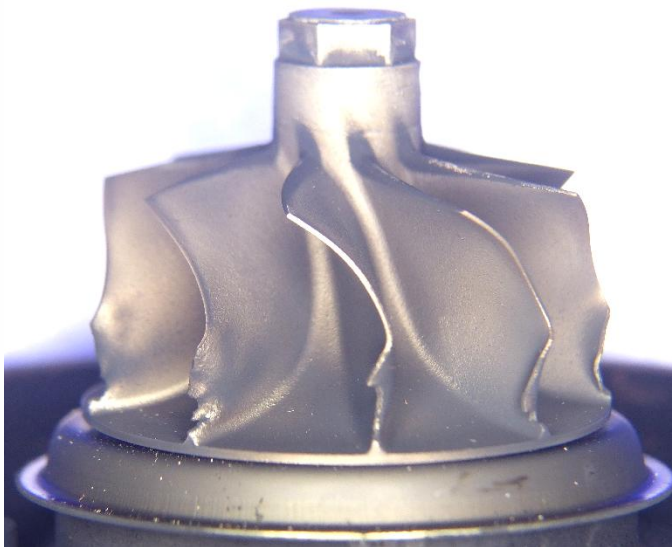
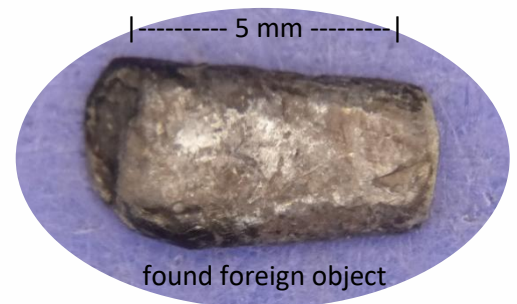
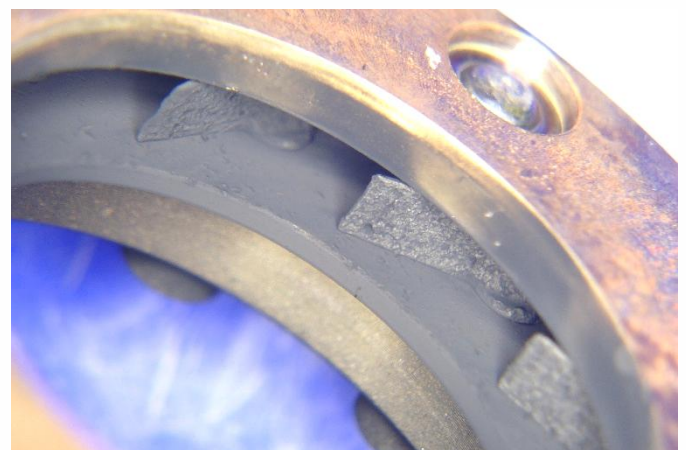
Vehicles with faults in the boost pressure control or signal amplitude of the position sensor are often diagnosed as having a stuck VTG unit, and only the turbocharger is replaced. Correctly, the exhaust back pressure from the diesel particulate filter or SCR catalytic converter is considered to be responsible here. However, there are also an increasing number of cases caused by foreign objects in the exhaust gas, which seriously damage the turbine wheel and the VTG unit. This results in the VTG sticking.

Chipped glow plugs are usually suspected when foreign objects cause damage.

In these vehicles, defective EGR valves and/or EGR coolers are the cause. During load changes, foreign objects are sucked into the exhaust manifold and, during the next acceleration, are forced through the turbocharger turbine.

Check the EGR valve and EGR cooler for damage and replace if necessary.

Check the glow plugs for proper functioning.
