Blue Print ADBP300173, ADF123613

Ford Galaxy III (15), Mondeo V (14)

Engine: 2.0 TDCI

Clutch Kit, Concentric Slave Cylinder

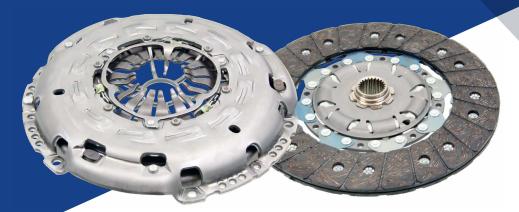
Incorrect diagnosis of a worn clutch or failed concentric slave cylinder (CSC) where the clutch pedal is reported to not fully release to its correct height after it has been depressed. The clutch still engages and disengages correctly and there is no evidence of hydraulic fluid loss from the master cylinder or the CSC.

Before considering replacing the clutch or CSC assembly, first check that the pivot pin is securely welded to the clutch pedal where the operating rod for the master cylinder is attached. The weld to the pivot pin for the clutch pedal is known to partially fail, allowing the pivot pin to bind between the pedal and the pedal box. This creates enough friction to stop the pedal from returning to the correct position. The clutch master cylinder operating rod also can sheer at the master cylinder end, however this is very rare.

Unfortunately, the pivot pin is not available as a separate item and is sold by the vehicle manufacturer as the clutch pedal assembly. The operating rod is also not available separately and is supplied with the clutch master cylinder assembly.
