# Technical Bulletin

## Wheel Hub - CHA045

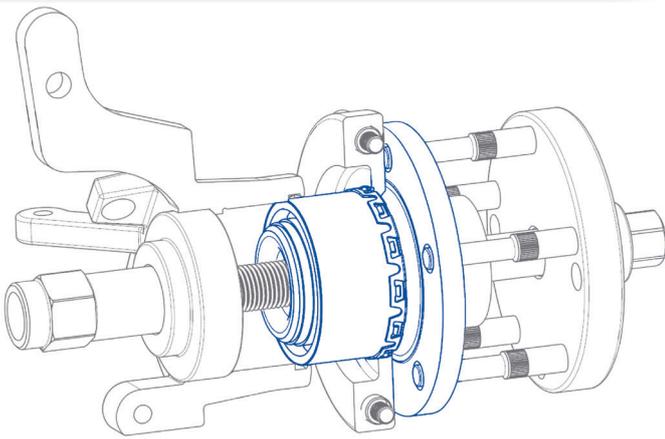
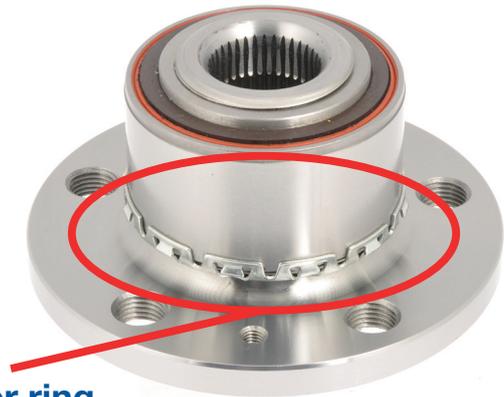
Metal outer ring

The metal outer ring must be fitted correctly to the outer bearing face. The correct tool must be used in order to apply the load to the outer race of the bearing. See diagram below.

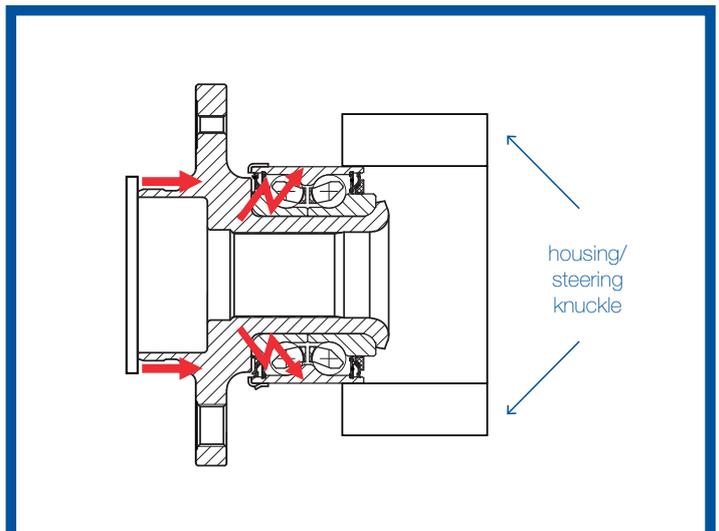
Incorrect installation will damage the bearing, leading to noise, excessive play and shortened service life.

This shows incorrect installation process which leads to the problems mentioned above.
