Turbocharger damage in PSA motors

1.6 HDi (9HX) and 1.6 HDi (9HY/9HZ)

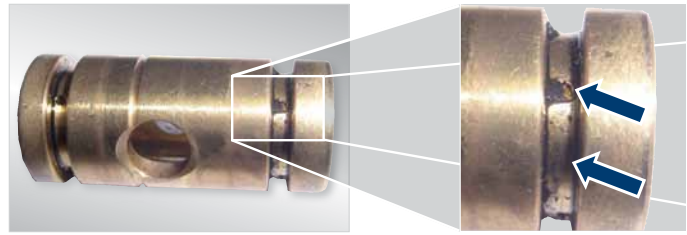
ill. 2: Soot and dirt deposits on the radial bearing

- Inspect intake manifold just beyond the mouth area of the crankcase ventilation and clean if necessary.
- Disassemble the charge-air cooler, empty out oil, wash out thoroughly.
