SI 0088
For technical personnel only!
1/1

SERVICE INFORMATION

VACUUM PUMP DAMAGE

INSUFFICIENT LUBRICATION DUE TO INCORRECT ASSEMBLY

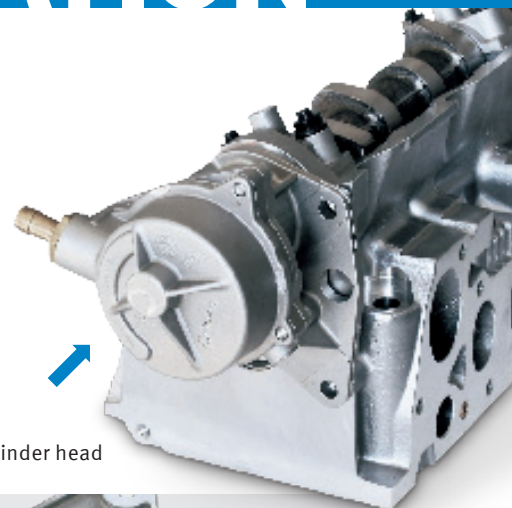
Vacuum pump
fitted to the cylinder head

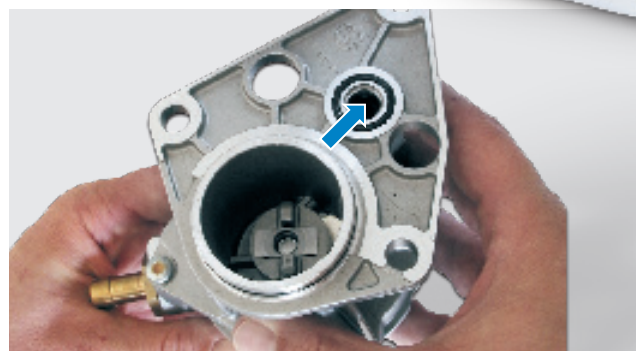
Important: proper lubricating oil supply to the vacuum pump

If this is not done, the vacuum pump will suffer a total failure due to insufficient lubrication already when being operated for a short period of time.

In the case of vacuum pumps which are driven by the camshaft, this closure screw must be removed from the cylinder head.
