TSB - GM18

Identifying Dual Mass Flywheel Failure

FGM120DM/FFI116DM

Applies to ClutchPro kits;

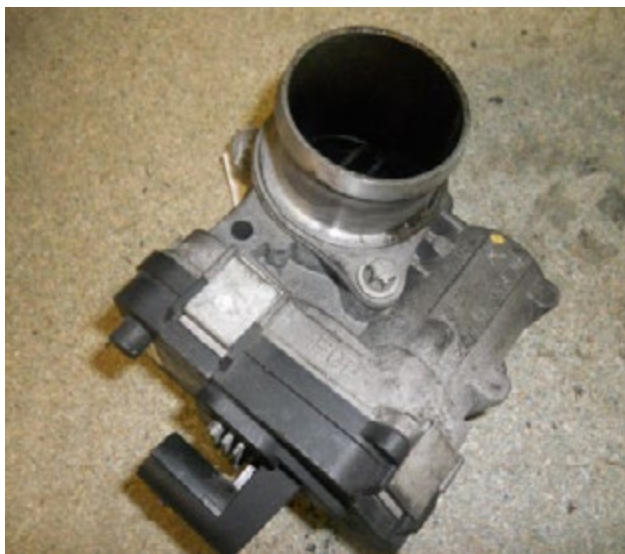
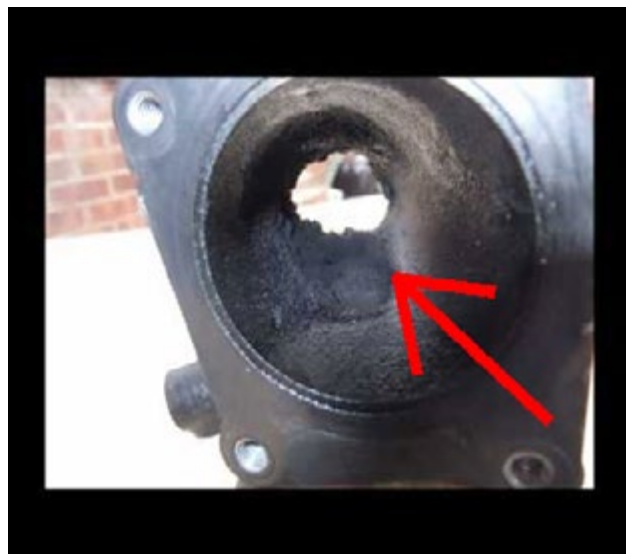
In the vehicles which use the above ClutchPro kit there has been incorrect diagnosis of Dual Mass Flywheel (DMF) failure. A common cause of the incorrect diagnosis is due to the throttle body housing having high levels of contaminants (soot) not allowing the throttle body to work correctly when switching the engine off. These contaminants do not allow the throttle body butterfly to close allowing a drop in pressure within the engine causing an uneven crankshaft rotation. This uneven crankshaft rotation transfers vibration through the driveline which does not allow the DMF to dampen, this presents itself as a metallic noise.

REPLACING THE DMF WILL NOT ELIMINATE THESE NOISES!

ClutchPro recommend the following actions;

- Check the engine management system for any coding errors.
- Visually inspect the throttle body and clean if necessary.
- Inspect the throttle valve which must close when the engine is stopped.

Once all the above checks have been performed and the metallic noise is still present the decision to replace the DMF should be made.
