Bulletin Ref: TB19a

Ford Alternator Broken Wire

AAL1045

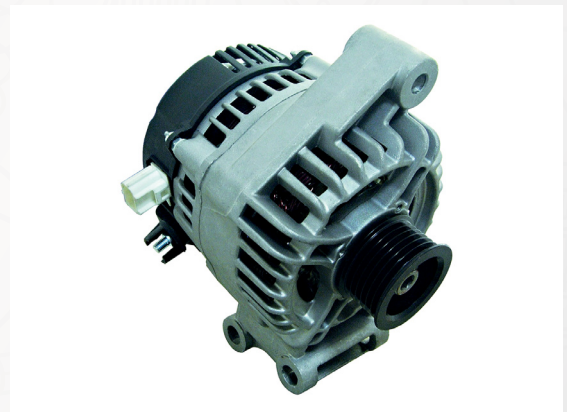
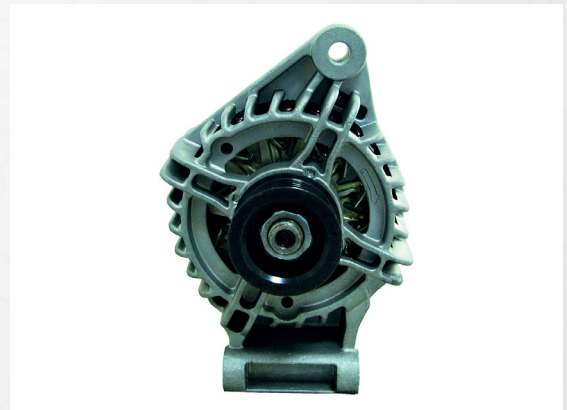
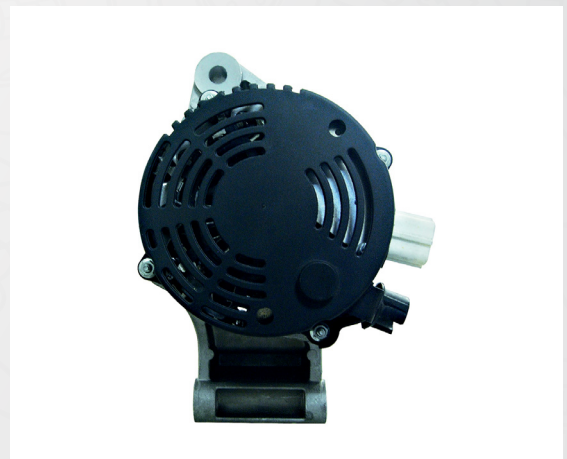
1. One Amp fuse is sometimes defective, this can be found in the main fuse box in the engine bay.
2. The wiring harness from factory is too tight resulting in broken wires in the harness, the wires are mostly broken under headlight.
3. Corrosion inside the multi connector on the rear of the unit is also common.
