Bulletin Ref: TB19a

Ford Broken Wire

AAL1139

Possible issues relating to charging problems:

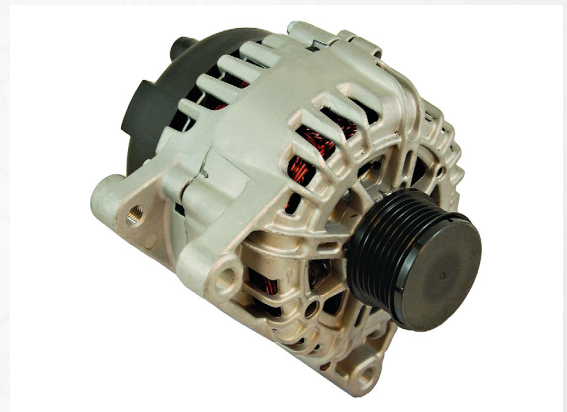
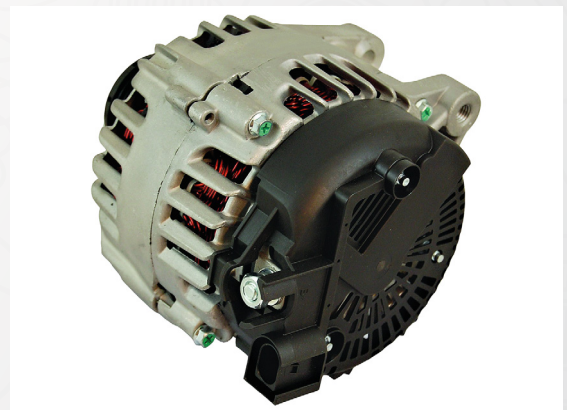
1. One Amp fuse is sometimes defective, this can be found in the main fuse box in the engine bay
2. The wiring harness from factory is too tight resulting in broken wires in the harness, the wires are mostly broken under headlight
3. Corrosion inside the multi connector on the rear of the unit is also common.
