Bulletin Ref: TB19a

Ford Broken Wire

AAL1146

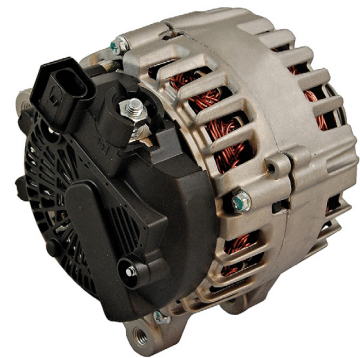
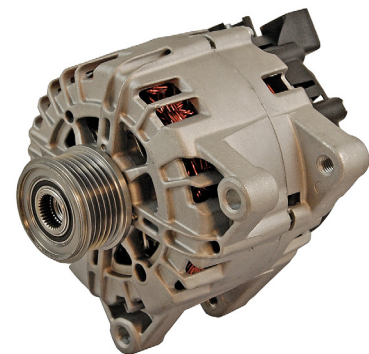
Possible issues relating to charging problems:

1. One Amp fuse is sometimes defective, this can be found in the main fuse box in the engine bay
2. The wiring harness from factory is too tight resulting in broken wires in the harness, the wires are mostly broken under headlight
3. Corrosion inside the multi connector on the rear of the unit is also common.
