Bulletin Ref: TB19a

## Ford Broken Wire

**AAL1373**

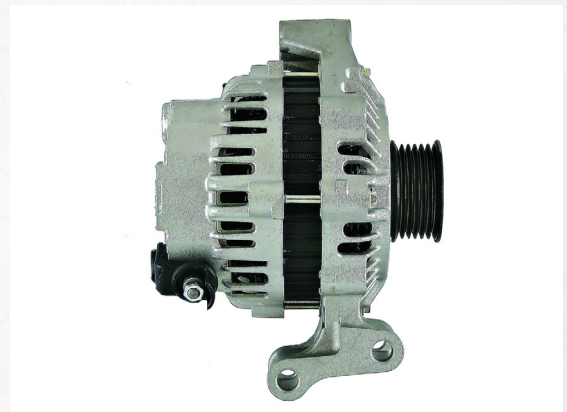
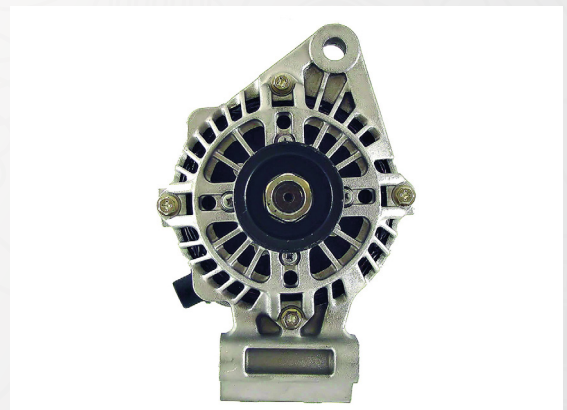
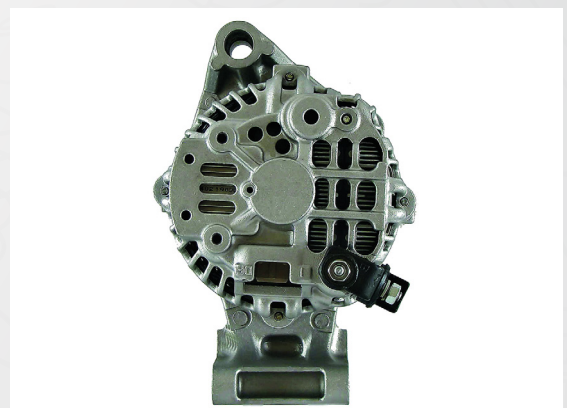
Possible issues relating to charging problems:

1. One Amp fuse is sometimes defective, this can be found in the main fuse box in the engine bay
2. The wiring harness from factory is too tight resulting in broken wires in the harness, the wires are mostly broken under headlight
3. Corrosion inside the multi connector on the rear of the unit is also common.
