Bulletin Ref: TB19a

## Ford Broken Wire

**AAL1692**

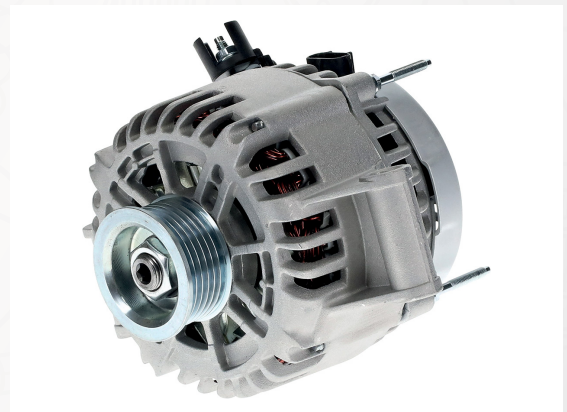
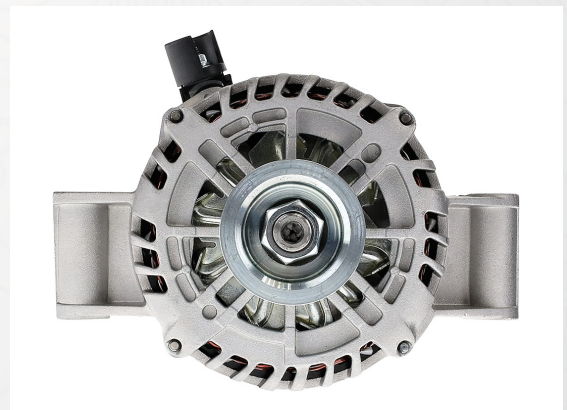
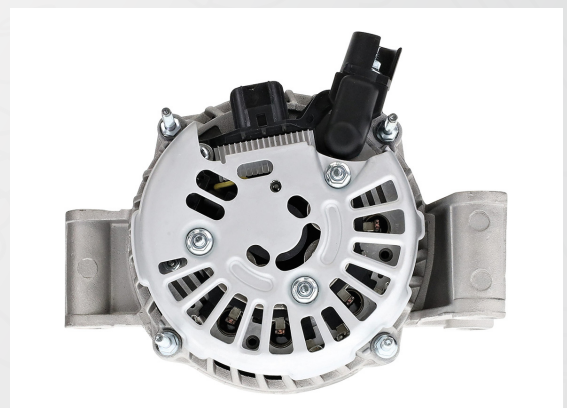
Possible issues relating to charging problems:

1. One Amp fuse is sometimes defective, this can be found in the main fuse box in the engine bay
2. The wiring harness from factory is too tight resulting in broken wires in the harness, the wires are mostly broken under headlight
3. Corrosion inside the multi connector on the rear of the unit is also common.
