**TECH
MATE**

Bulletin Ref: TB4a

AAL1747

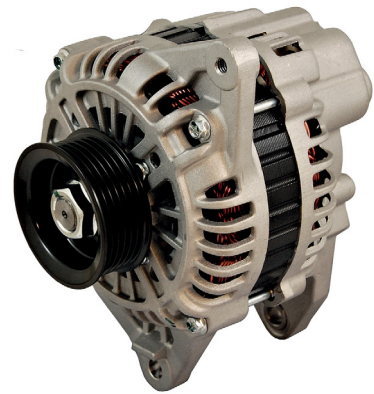
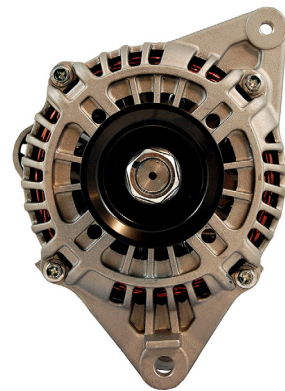
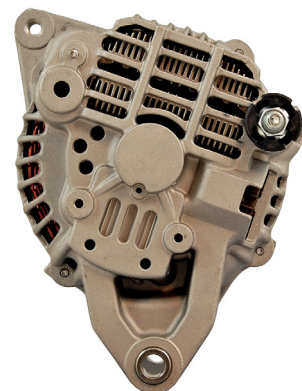
Poor or corroded connections on the rear of the alternator are common creating charging issues, this can also cause the charging light to illuminate when the unit is still charging.

Please double check before ordering and fitting.
